## FAIRFAX & SOUTH BALDWIN HILLS – CURRENT SETTING

# CASTAIC

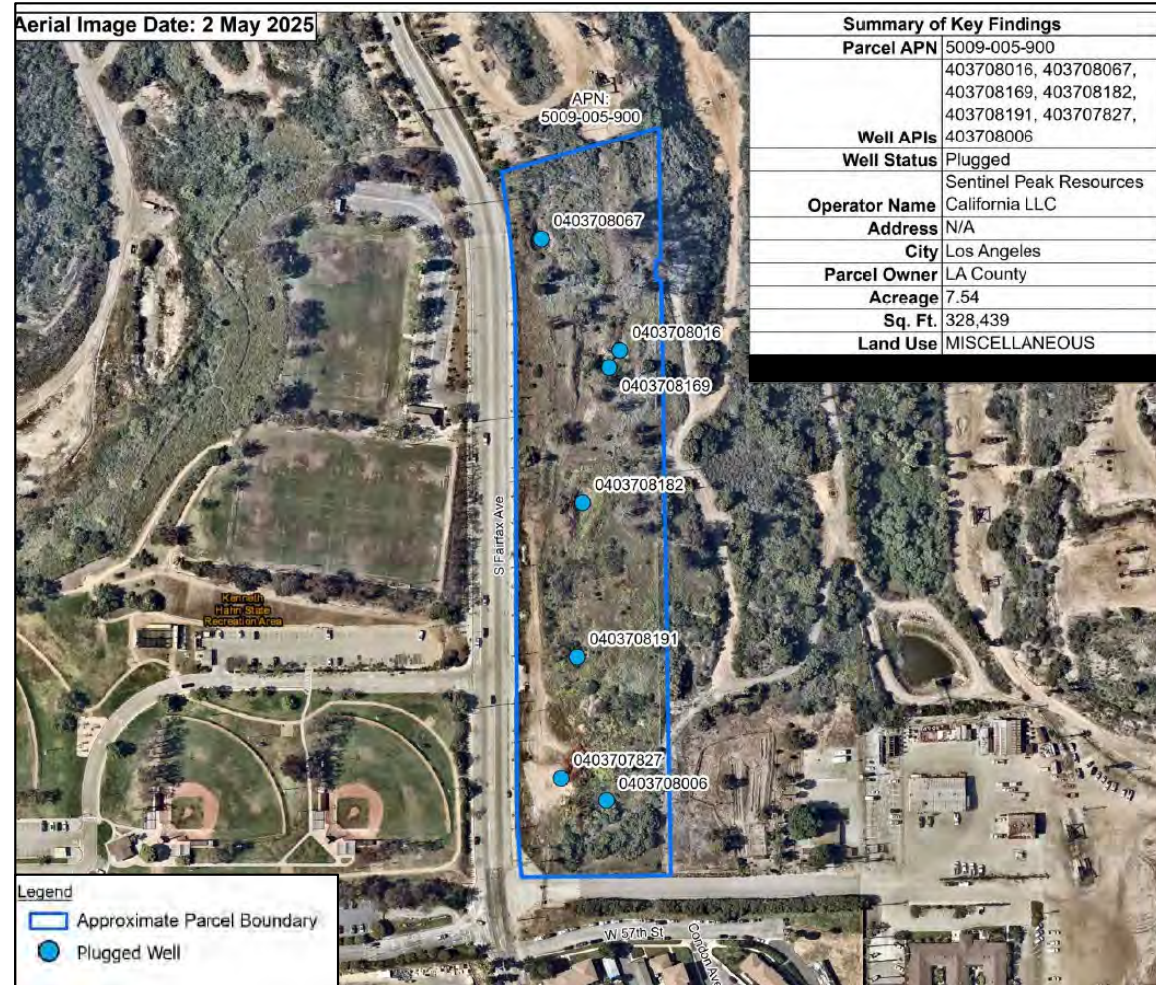
- Seven plugged wells generally located in line running north to south.
- Site is within a Priority Restoration Area (PRA).
- Site is located within the unincorporated Baldwin Hills area, across existing soccer and baseball fields.
- Wells may need to be re-abandoned to meet current CalGEM standards.

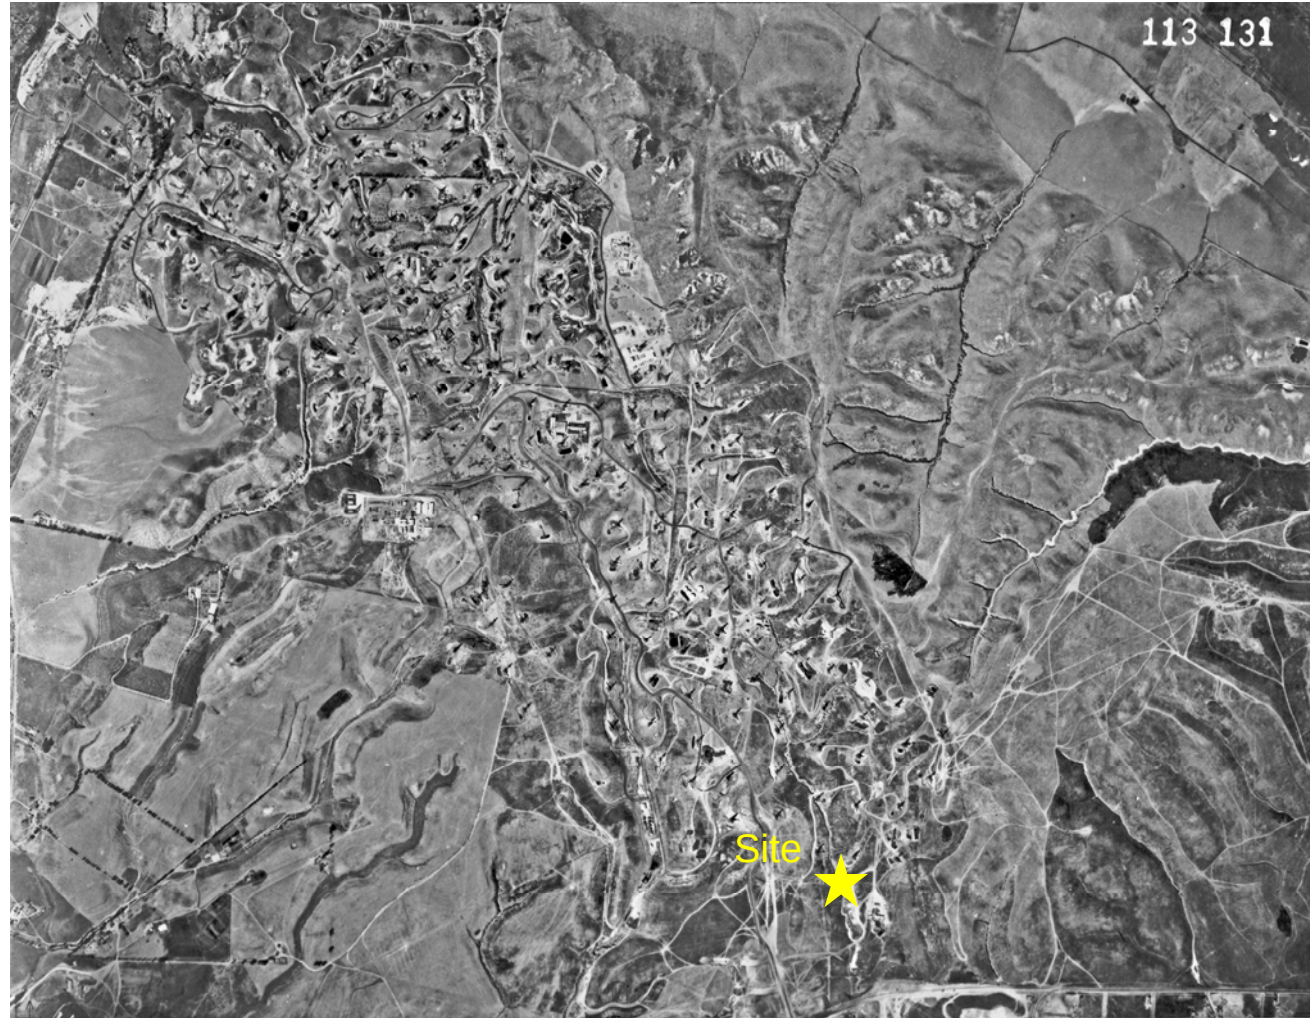
## FAIRFAX & SOUTH BALDWIN HILLS - 1927

- Aerial photograph from August 1 1927.
- Scale: 1:18,000
- Oil fields are the predominant land use, followed by agriculture.
- Residential use is minimal.

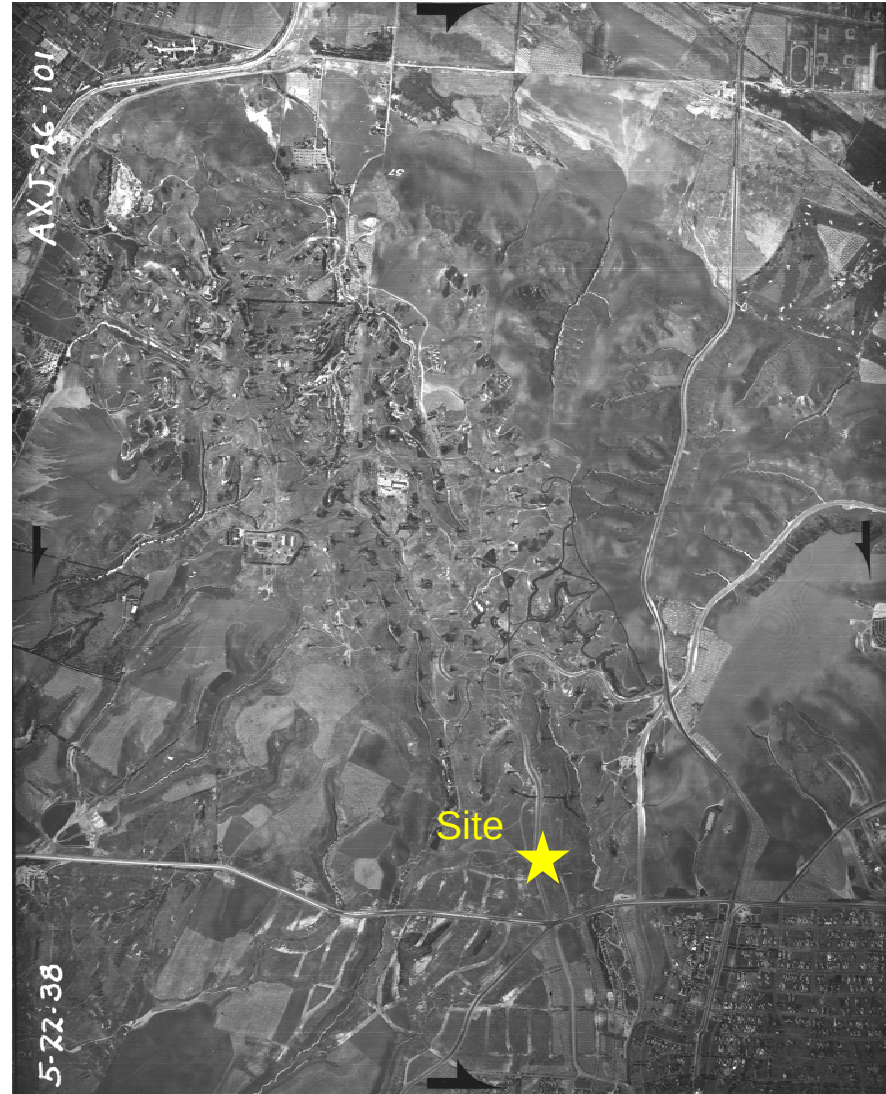
## FAIRFAX & SOUTH BALDWIN HILLS - 1938

- Aerial photograph from May 22 1938.
- Scale: 1:20,000
- Oil fields are the predominant land use, followed by agriculture.
- Expansion of residential use to the southeast.

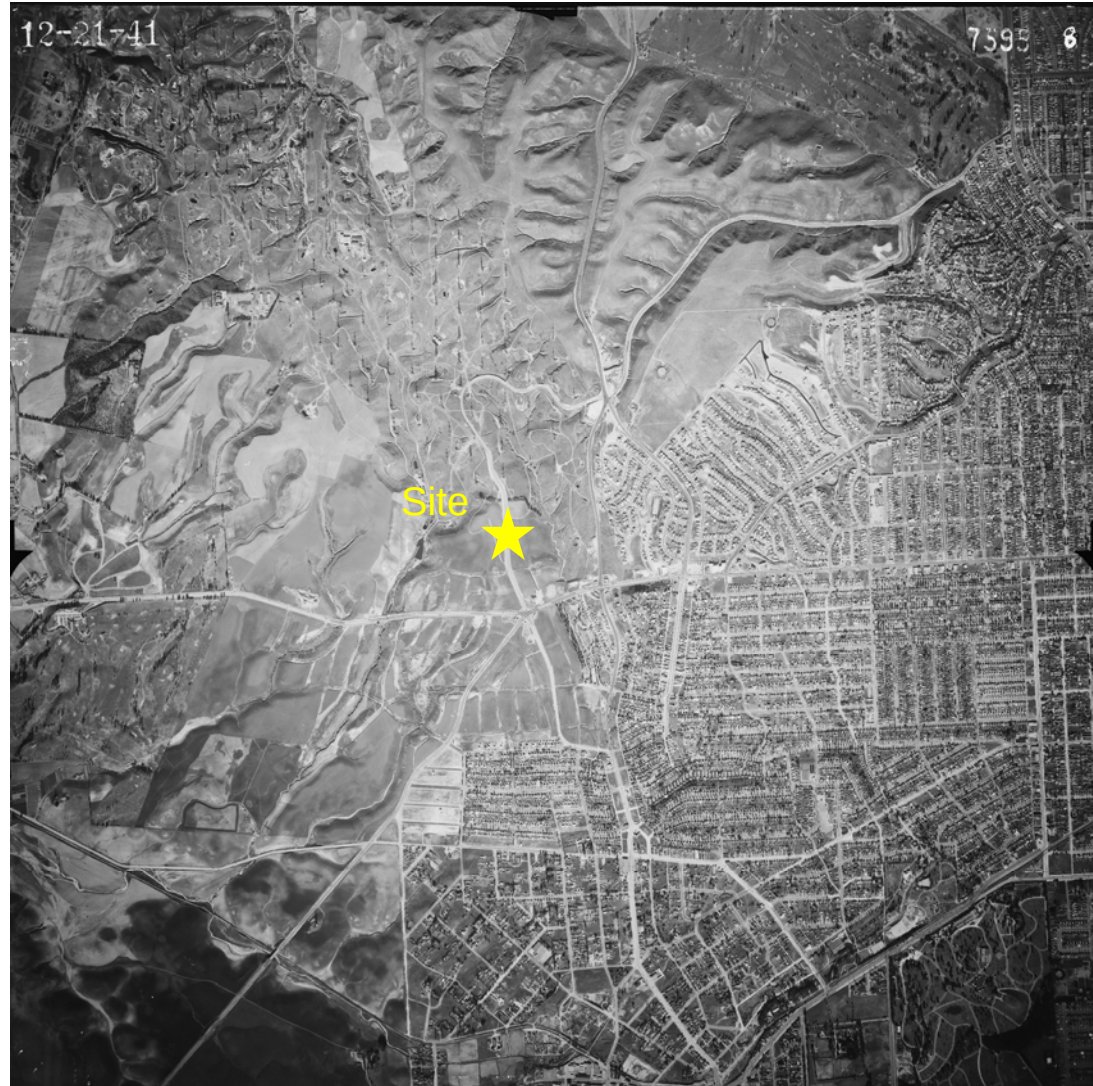
## FAIRFAX & SOUTH BALDWIN HILLS - 1941

- Aerial photograph from December 21 1941.
- Scale: 1:24,000
- Further expansion of residential land use towards the east, south and southeast.
- Oil fields remain active on Site and Site Vicinity (Baldwin Hills)

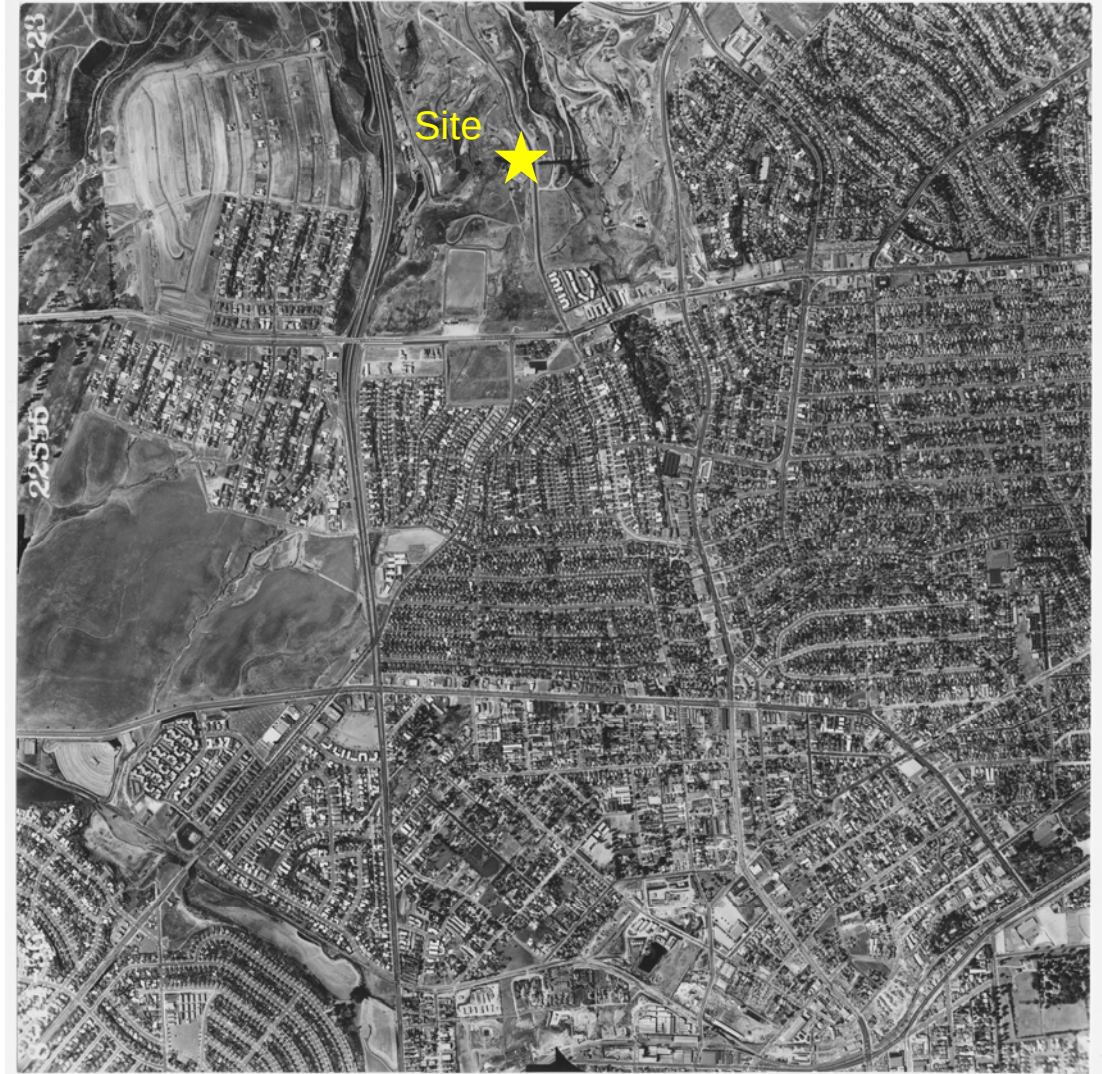
## FAIRFAX & SOUTH BALDWIN HILLS - 1956

- Aerial photograph from August 14 1956.
- Scale: 1:14,400
- Expansion of residential land use towards southwest.
- Oil fields remain active on Site and Site Vicinity (Baldwin Hills)
- Recreation park appears on south end of Site.

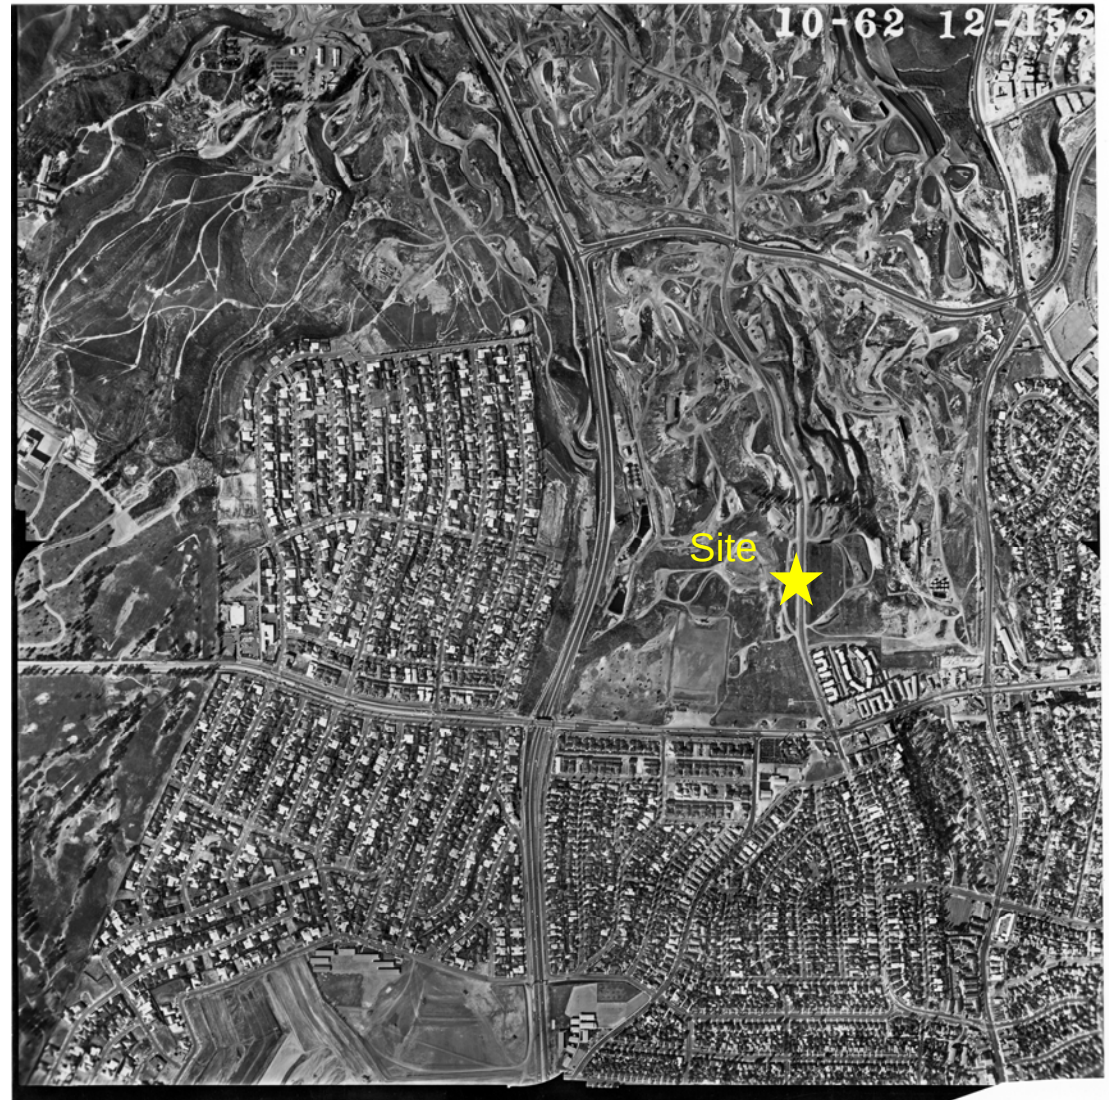
## FAIRFAX & SOUTH BALDWIN HILLS - 1962

- Aerial photograph from December 15 1962.
- Scale: 1:12,000
- Further expansion of residential land use towards the west.
- Oil fields remain active on most of the Site and Site Vicinity (Baldwin Hills)
- Recreation park expands slightly to the north.

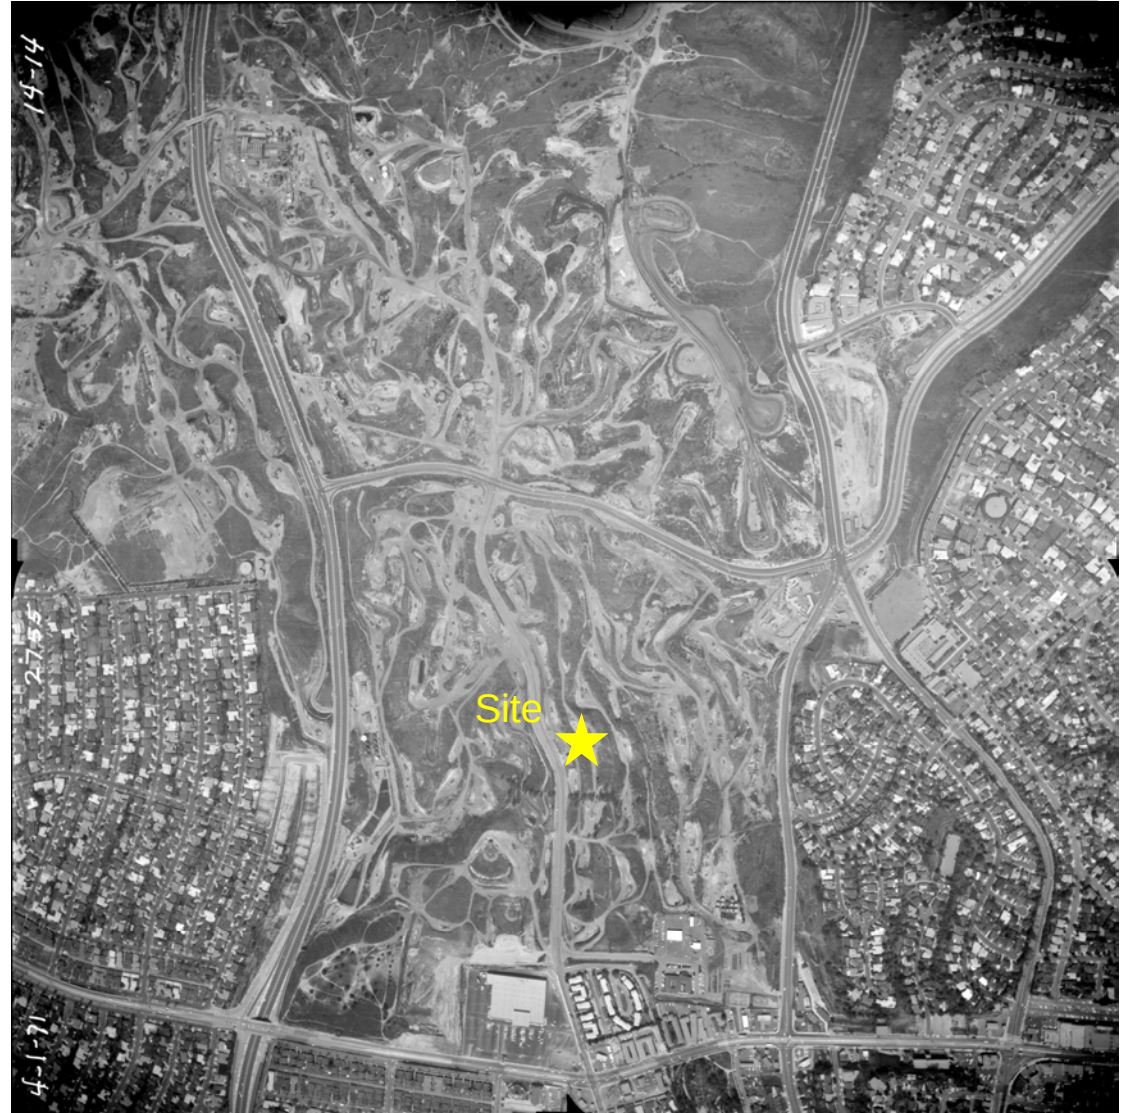
## FAIRFAX & SOUTH BALDWIN HILLS - 1971

- Aerial photograph from April 1 1971.
- Scale: 1:12,000
- Expansion of residential land use towards the northeast.
- Oil fields remain active on Site and Site Vicinity (Baldwin Hills)
- A new building with a parking lot appears within the recreation park.

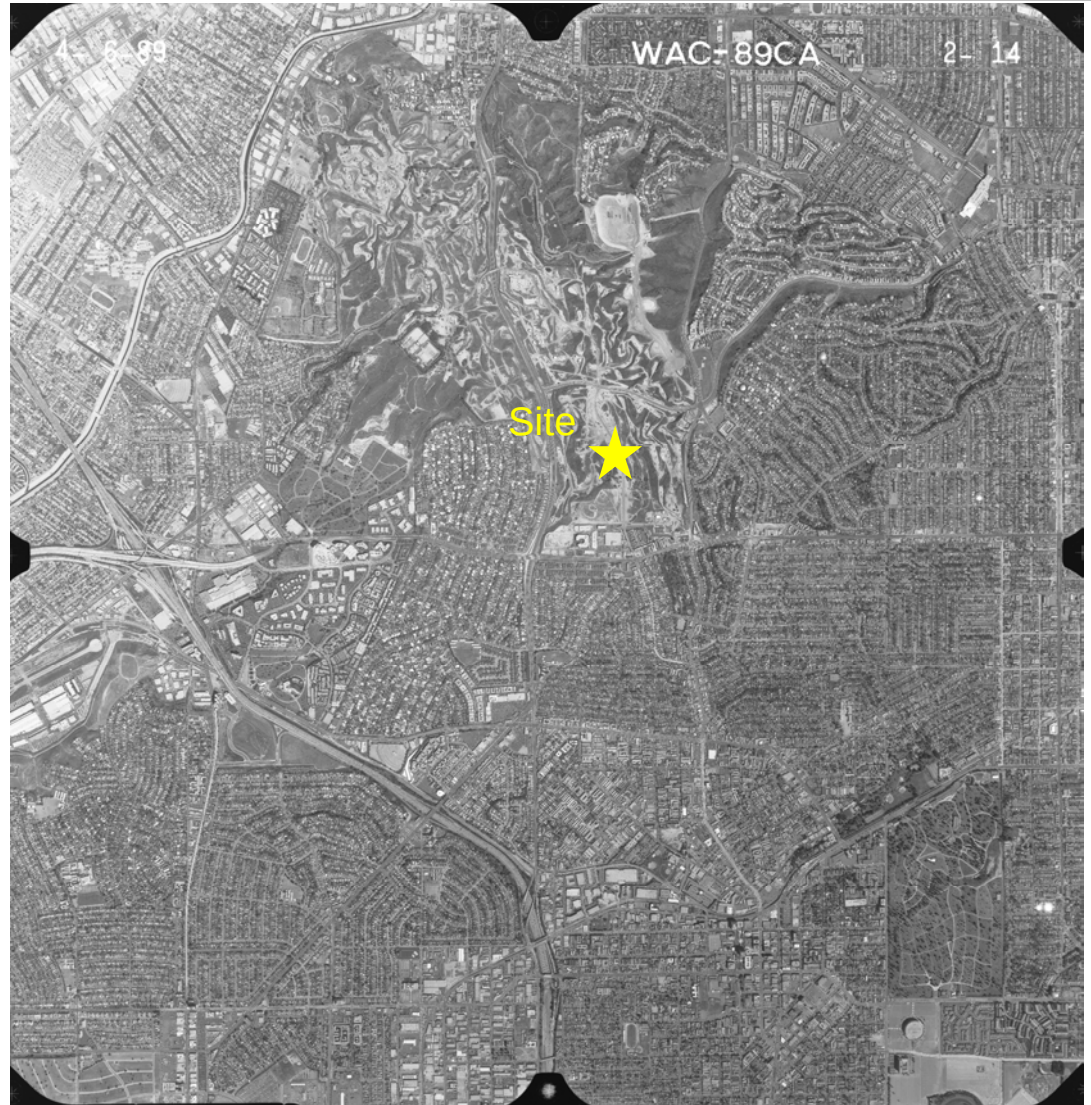
## FAIRFAX & SOUTH BALDWIN HILLS - 1989

- Aerial photograph from March 30 1989.
- Scale: 1:31,680
- Expansion of residential and some commercial land use in all directions.
- Oil fields remain active on Site
- Decrease of oil fields in the Site Vicinity.
- New buildings appear within the recreation park.

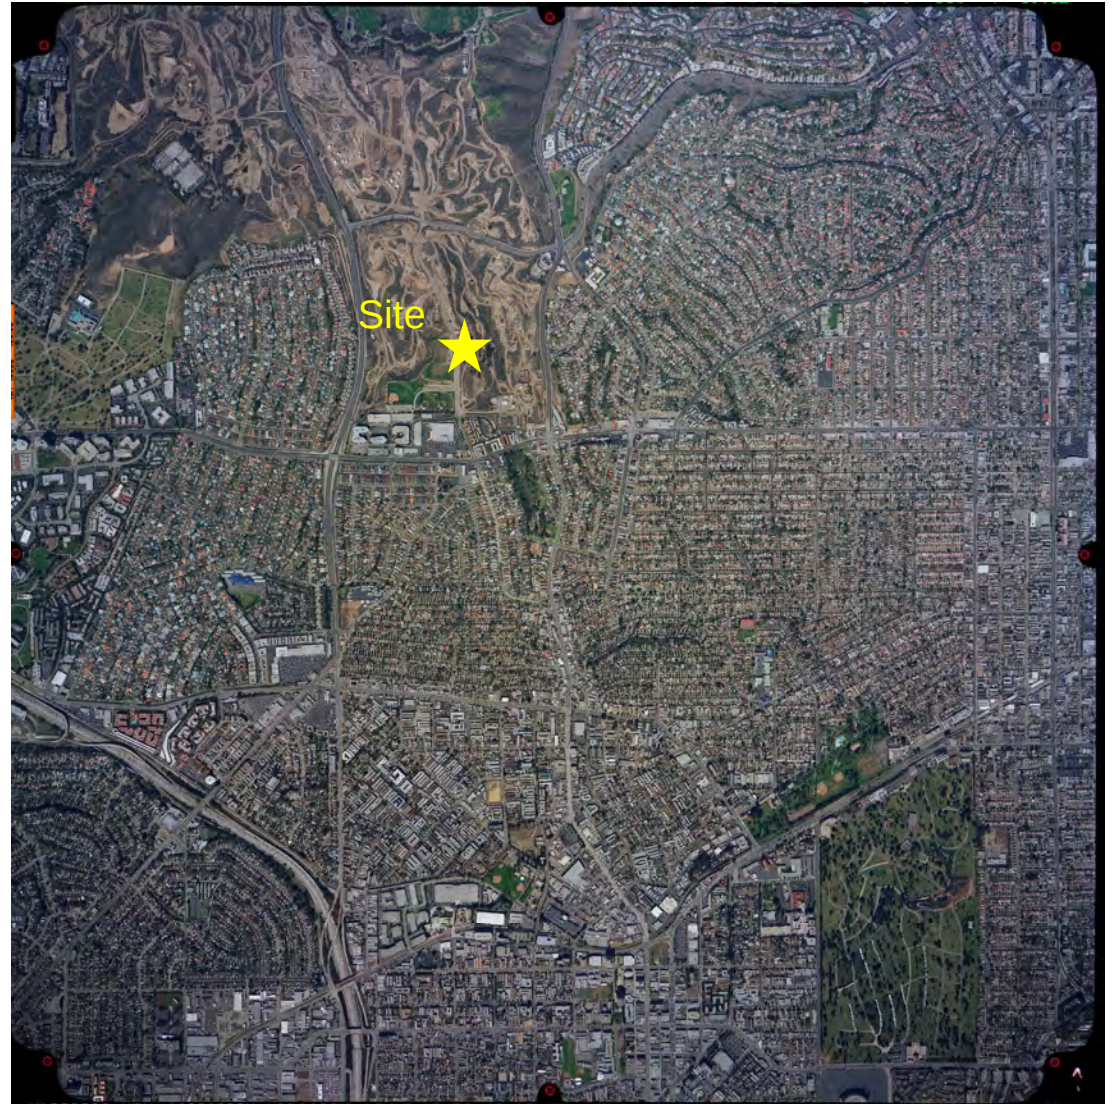
## FAIRFAX & SOUTH BALDWIN HILLS - 2007

- Aerial photograph from February 24, 2007.
- Scale: 1:24,000
- Predominant land use is residential, followed by oil fields and a recreation park.
- Oil fields remain active on Site and to the north of the recreation park.

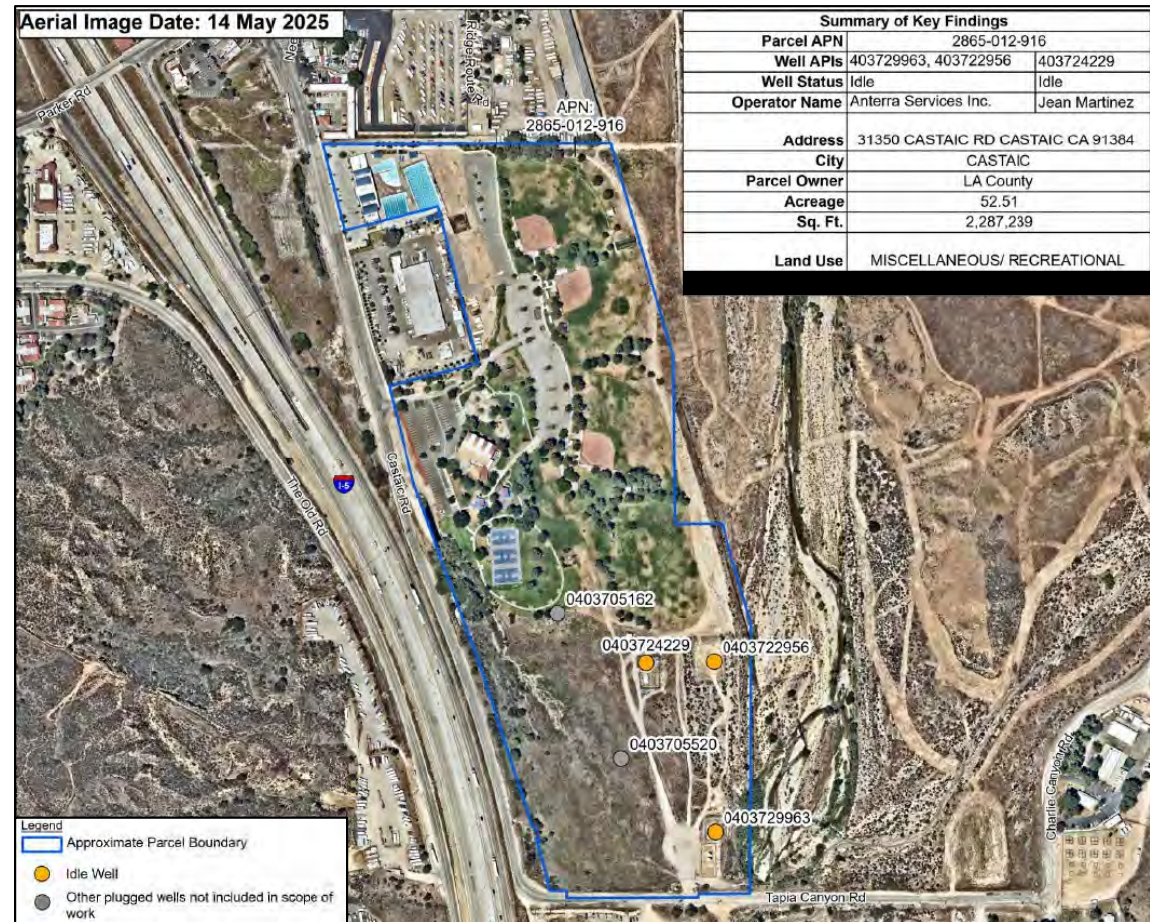
- Three idle wells, generally located in line running north to south, and one well to the south of the park.
- Site is not within a DAC or Priority Restoration Area.
- Site is located in the unincorporated community of Castaic, just south of the Castaic Sports Complex.

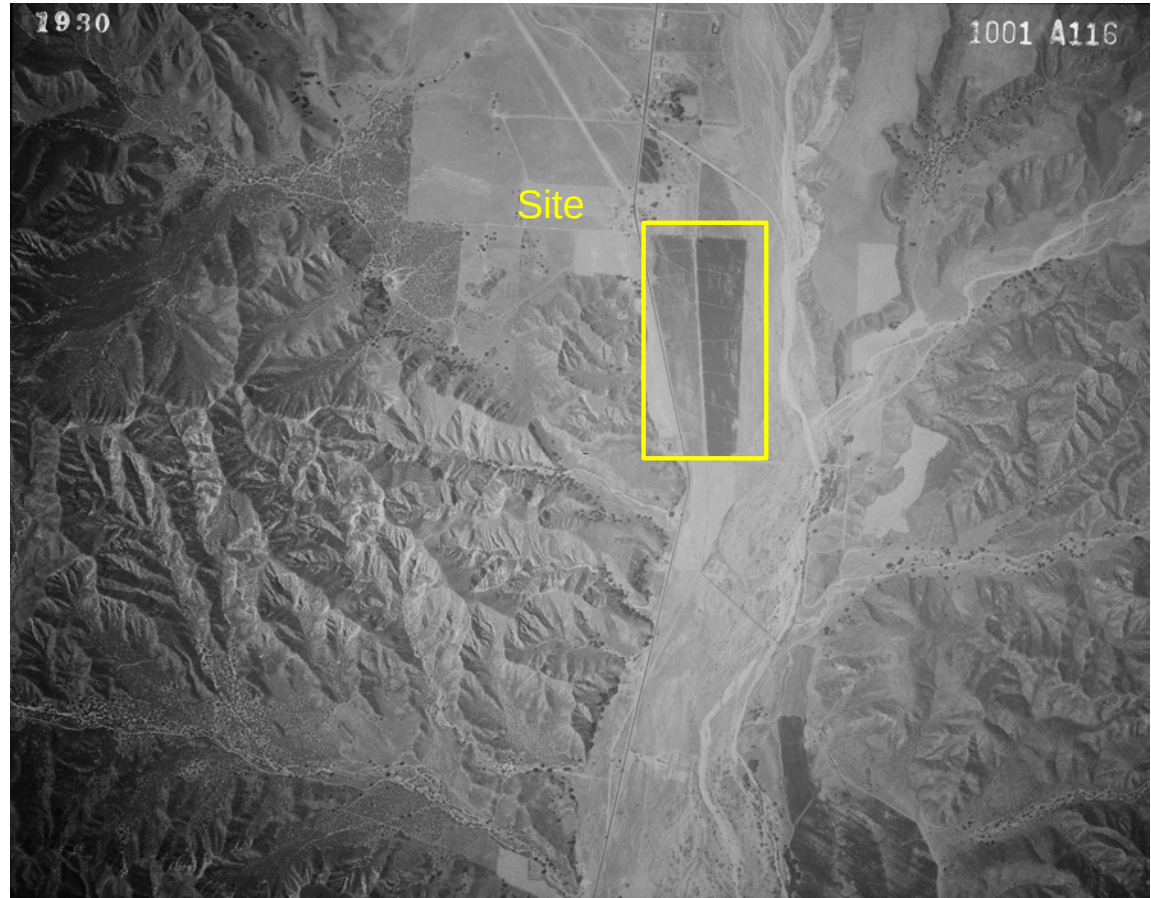
## CASTAIC - 1930

- Aerial image taken on July 18, 1930.
- Scale = 1:18,000
- The Site appears to be used for agriculture.
- Site vicinity is largely undeveloped with some agricultural land use.

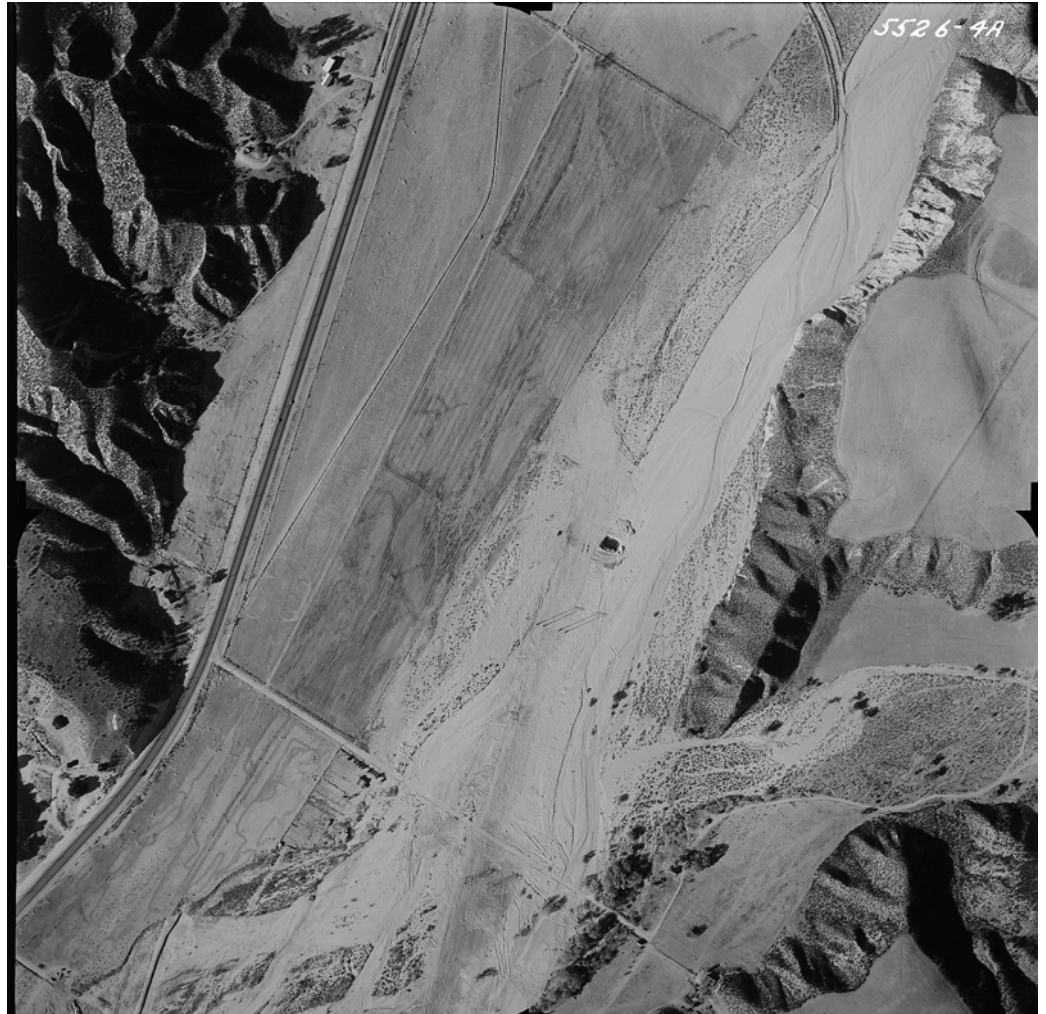
## CASTAIC – 1939

- Aerial image taken on January 1, 1939.
- Scale = 1:4,800
- The Site appears to remain as agricultural.
- Electrical power lines are present.
- Unknown sump-like feature appears along the east side of the property.
- A suspected residence appears directly south of the Site.

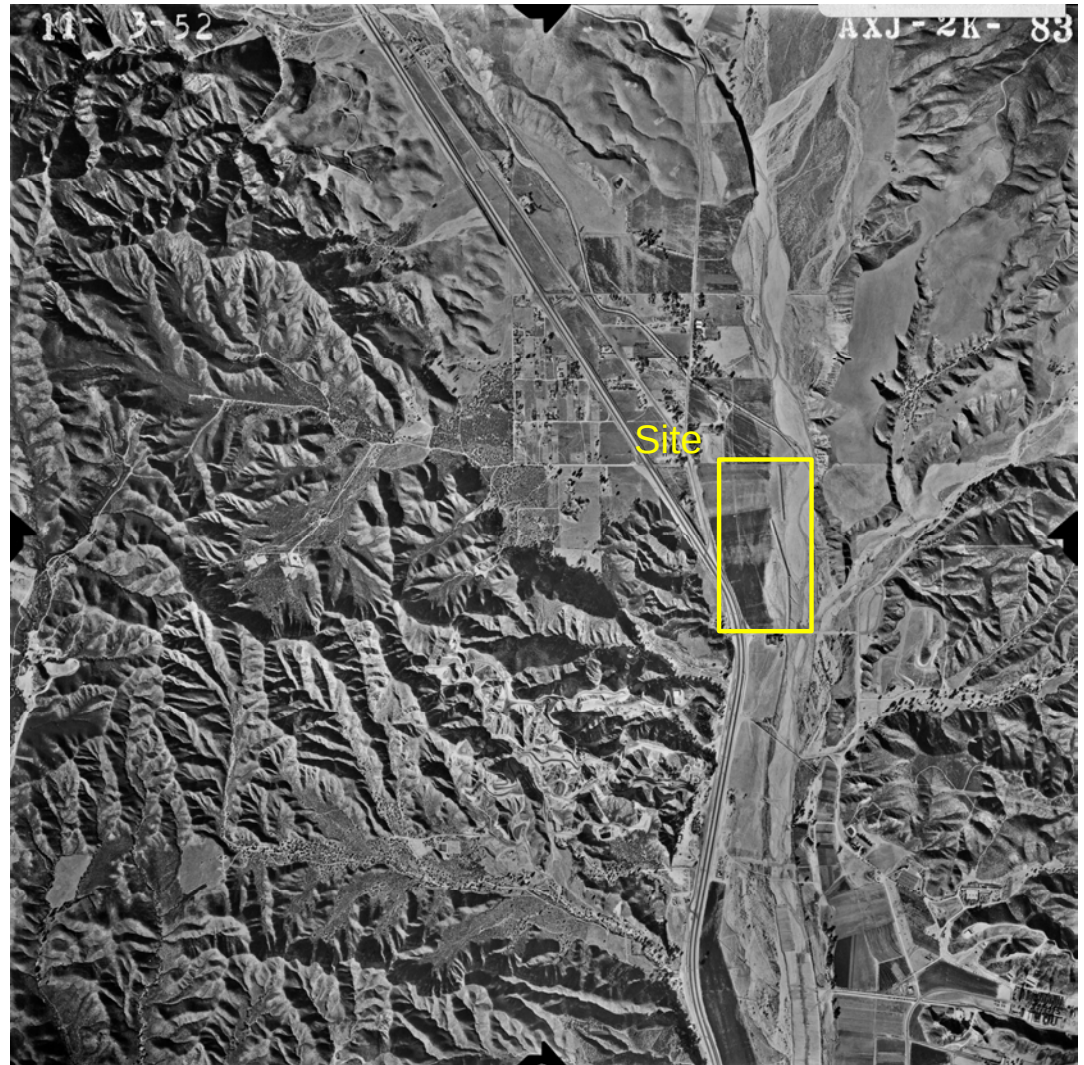
# CASTAIC - 1952

- Aerial image taken on November 3, 1952.
- Scale = 1:20,000
- The Site appears to remain as agricultural.
- A suspected oil derrick appears on the Southern end of the Site.
- Some expansion of residential and agricultural land use to the northwest of the Site.

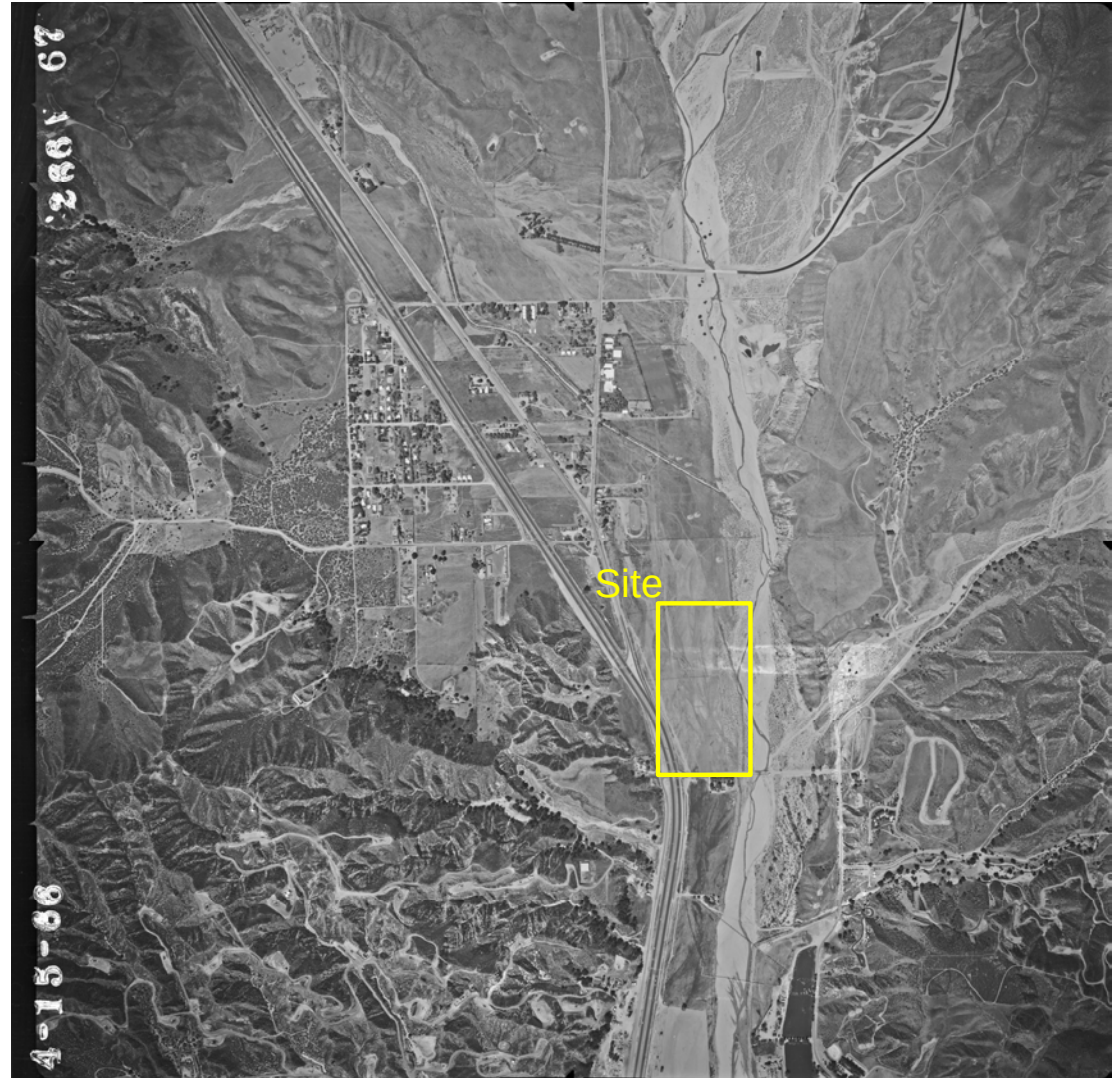
# CASTAIC - 1966

- Aerial image taken on April 13, 1966.
- Scale = 1:14,400
- The Site appears to remain as agricultural.
- The suspected oil derrick remains on the Southern end of the Site.
- Expansion of the suspected residence directly south of the Site.

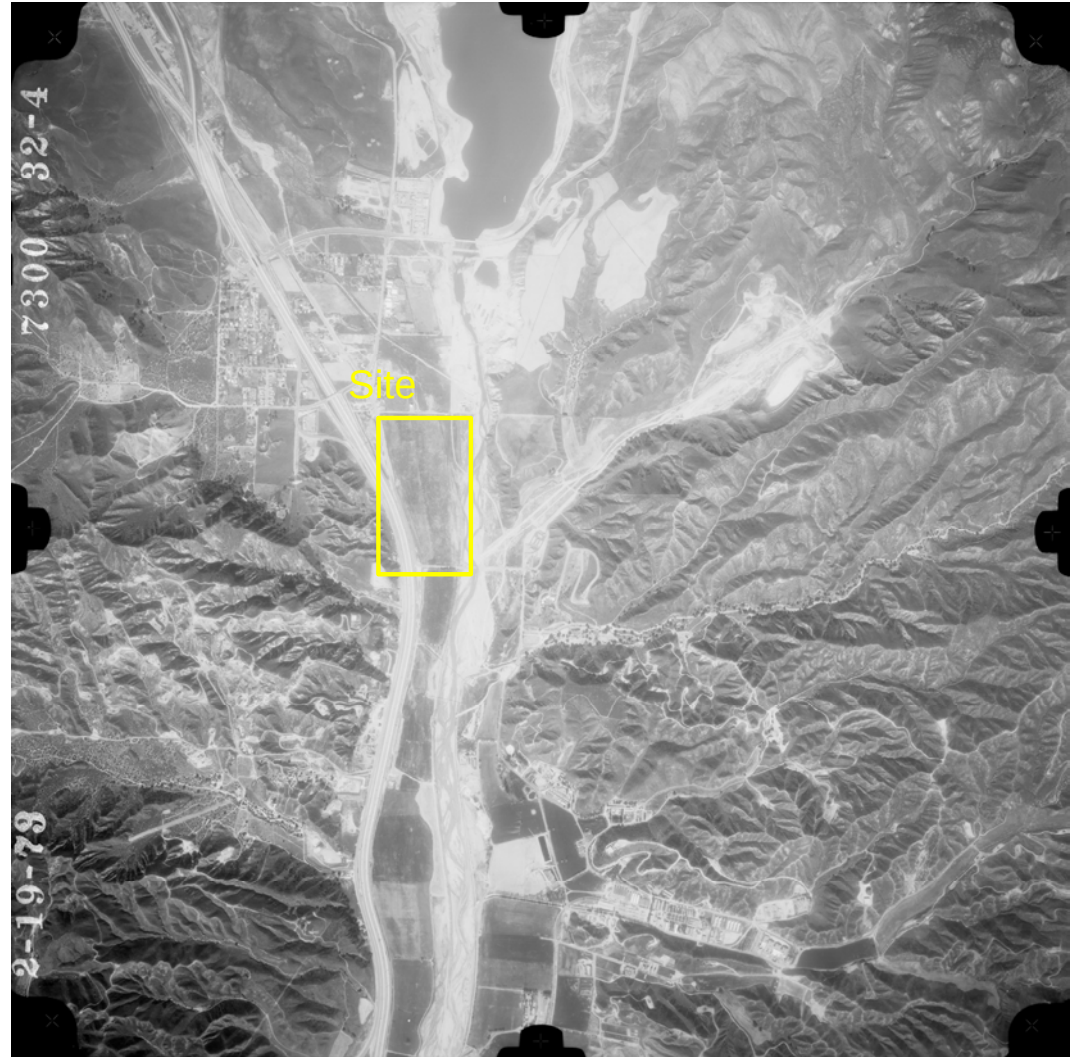
# CASTAIC - 1973

- Aerial image taken on February 19, 1973.
- Scale = 1:24,000
- The Site appears to remain as agricultural.
- Oil field activities are not obvious on the Site, but suspected industrial buildings are present to the southeast of the Site.
- Suspected residence to the South of Site is no longer present.
- Further expansion of residential land use to the northwest of the Site.

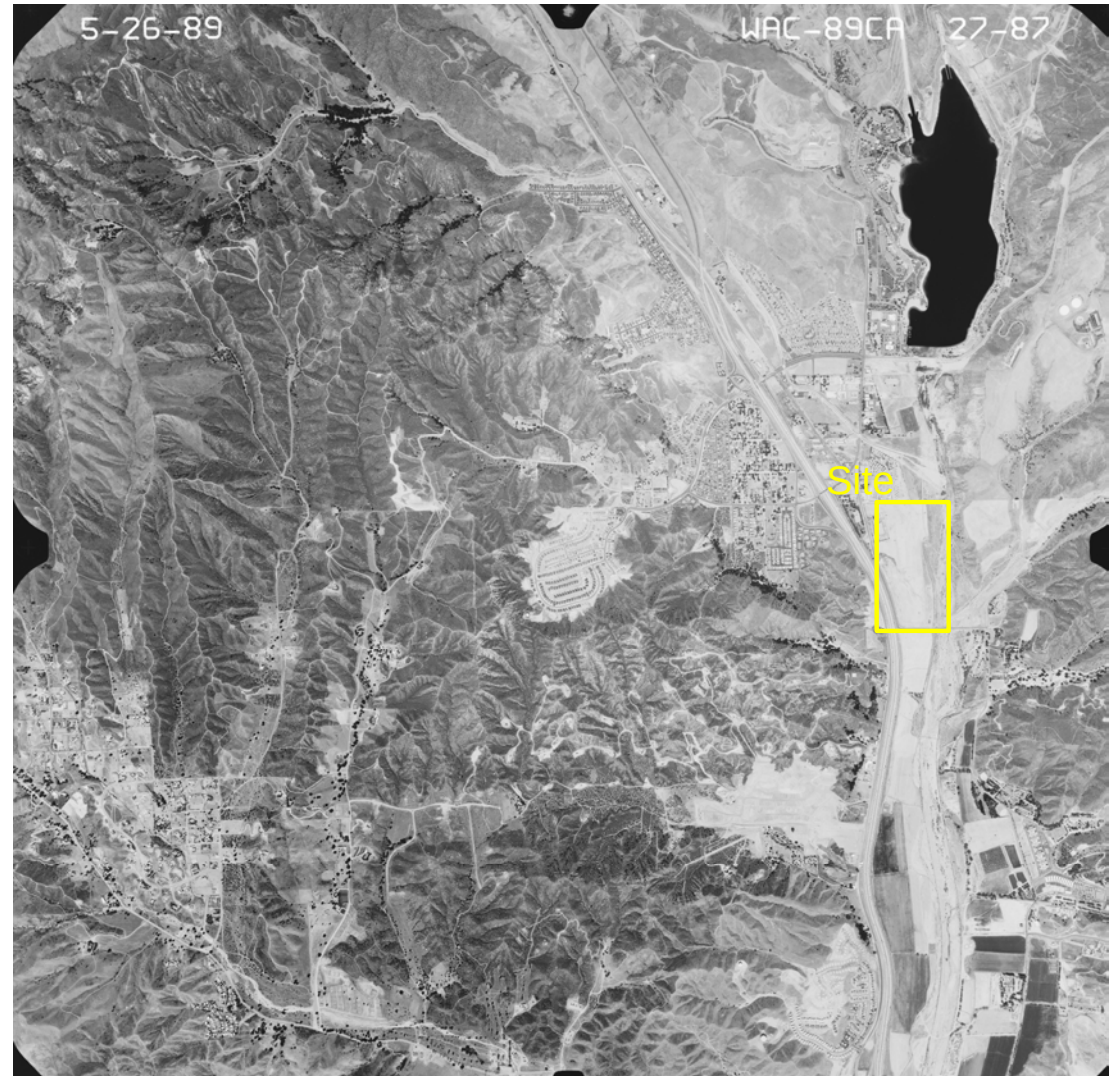
# CASTAIC - 1989

- Aerial image taken on May 26, 1989.
- Scale = 1:31,680
- The Site appears vacant with some commercial development in the northwest area.
- Approximately 2 oil wells appear near the southeast area of the Site.
- Further development of industrial buildings to the southeast of the Site.
- Further expansion of residential land use to the northwest of the Site.
- Commercial development to the north of the Site.

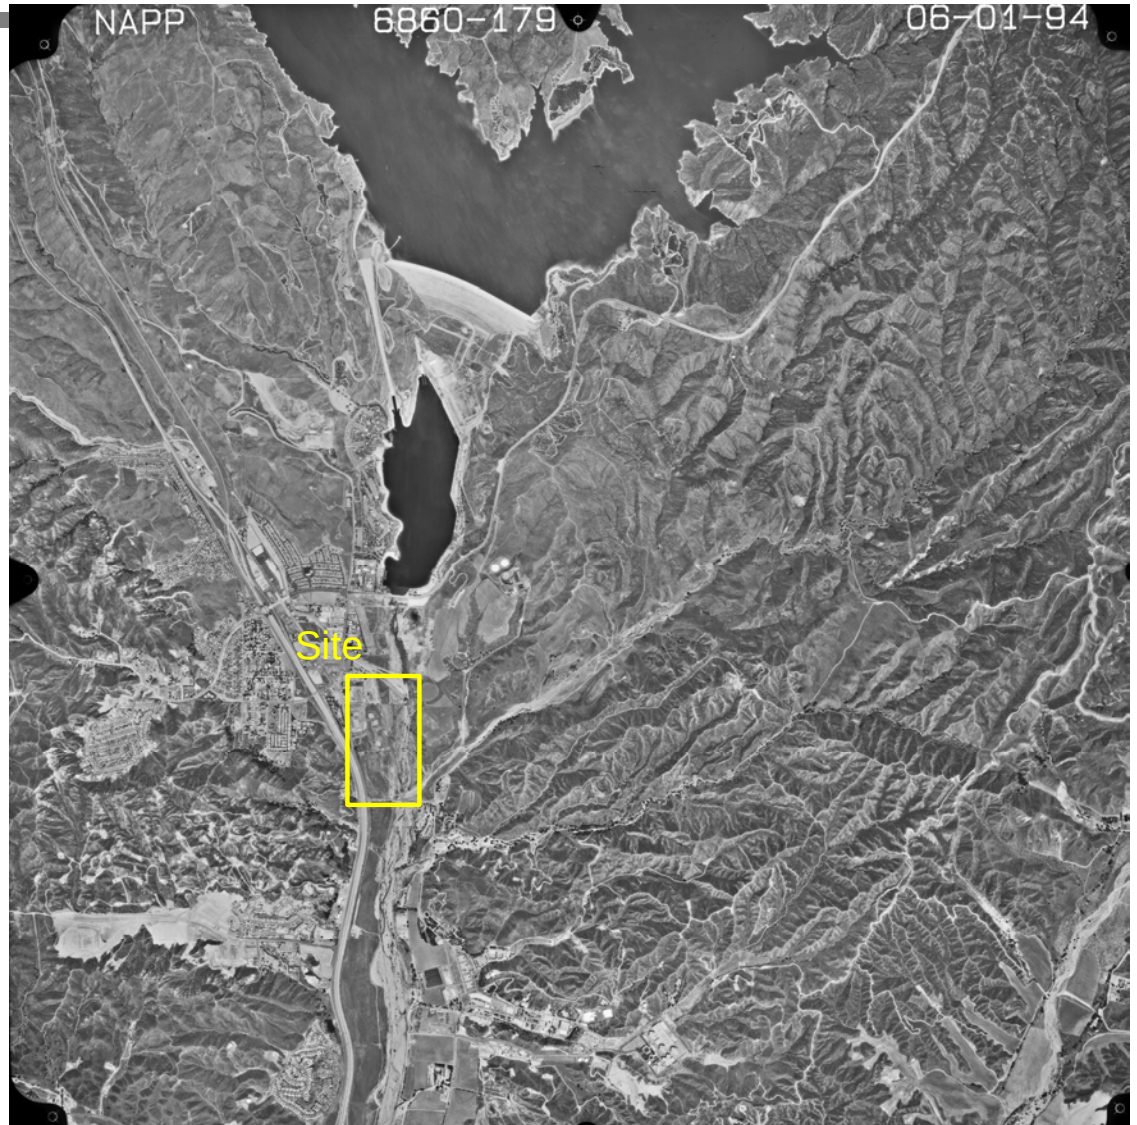
## CASTAIC - 1994

- Aerial image taken on June 1, 1994.
- Scale = 1:40,000
- The northern area of Site is redeveloped into a recreational park; southern area remains undeveloped.
- Oil field activities are present on the southeast area of the Site.
- Industrial buildings remain present to the southeast of the Site.
- Expansion of residential land use to the west, northwest, and south of the Site.
- Commercial development to the north of the Site.

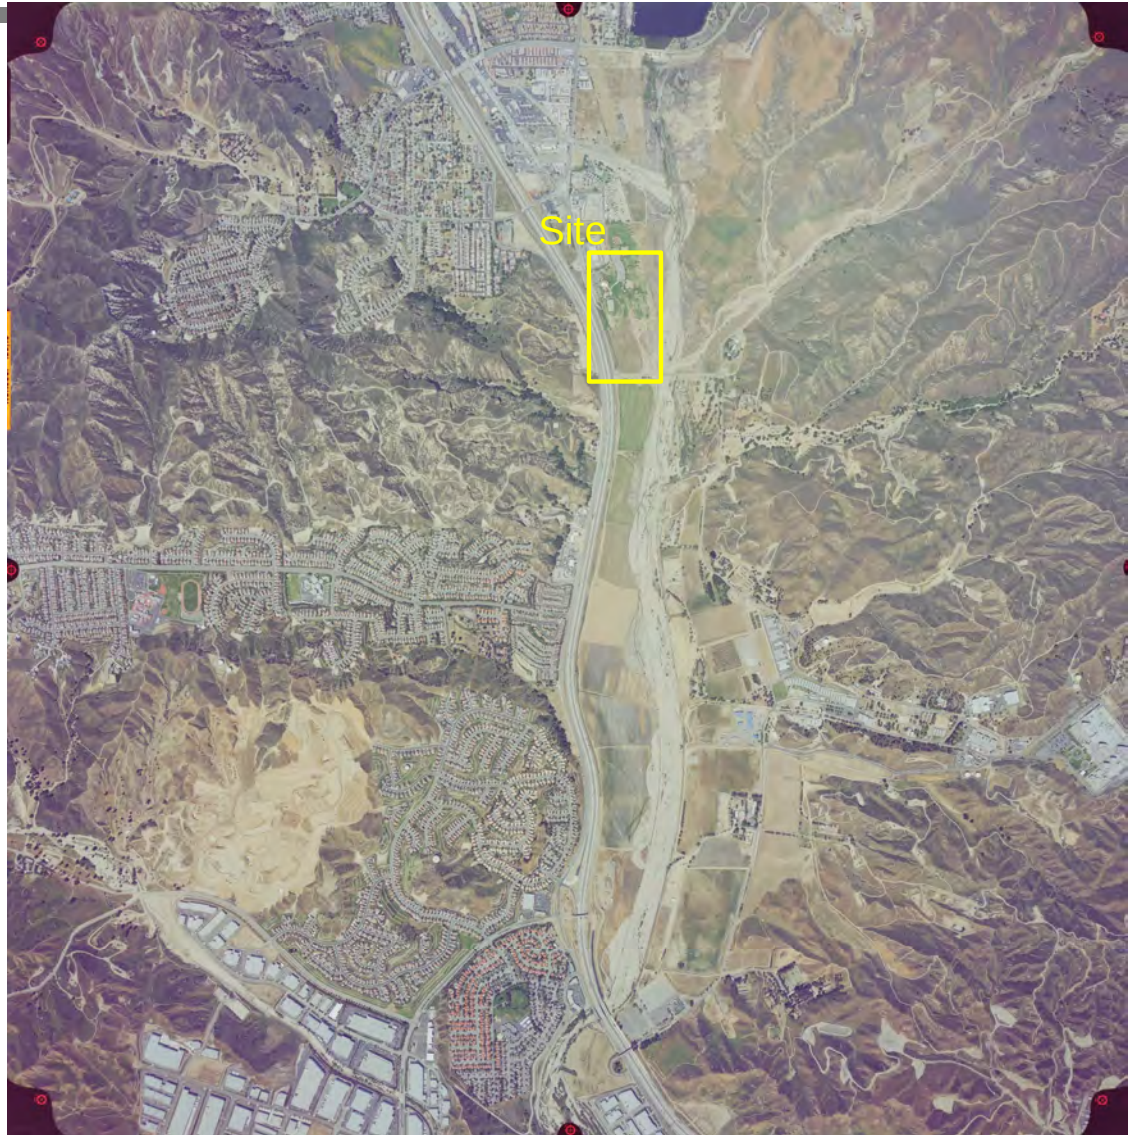
# CASTAIC - 2008

- Aerial image taken on April 14, 2008.
- Scale = 1:25,000
- The northern area of Site remains a recreational park; southern area remains undeveloped
- Oil field activities are present on the southeast area of the Site.
- Industrial buildings remain present to the southeast of the Site.
- A new building appears to the south of the Site,
- Expansion of residential land use to the west, northwest, and south of the Site.

Commercial development to the north of the Site.
