## FAIRFAX & SOUTH BALDWIN HILLS – CURRENT SETTING

# CASTAIC

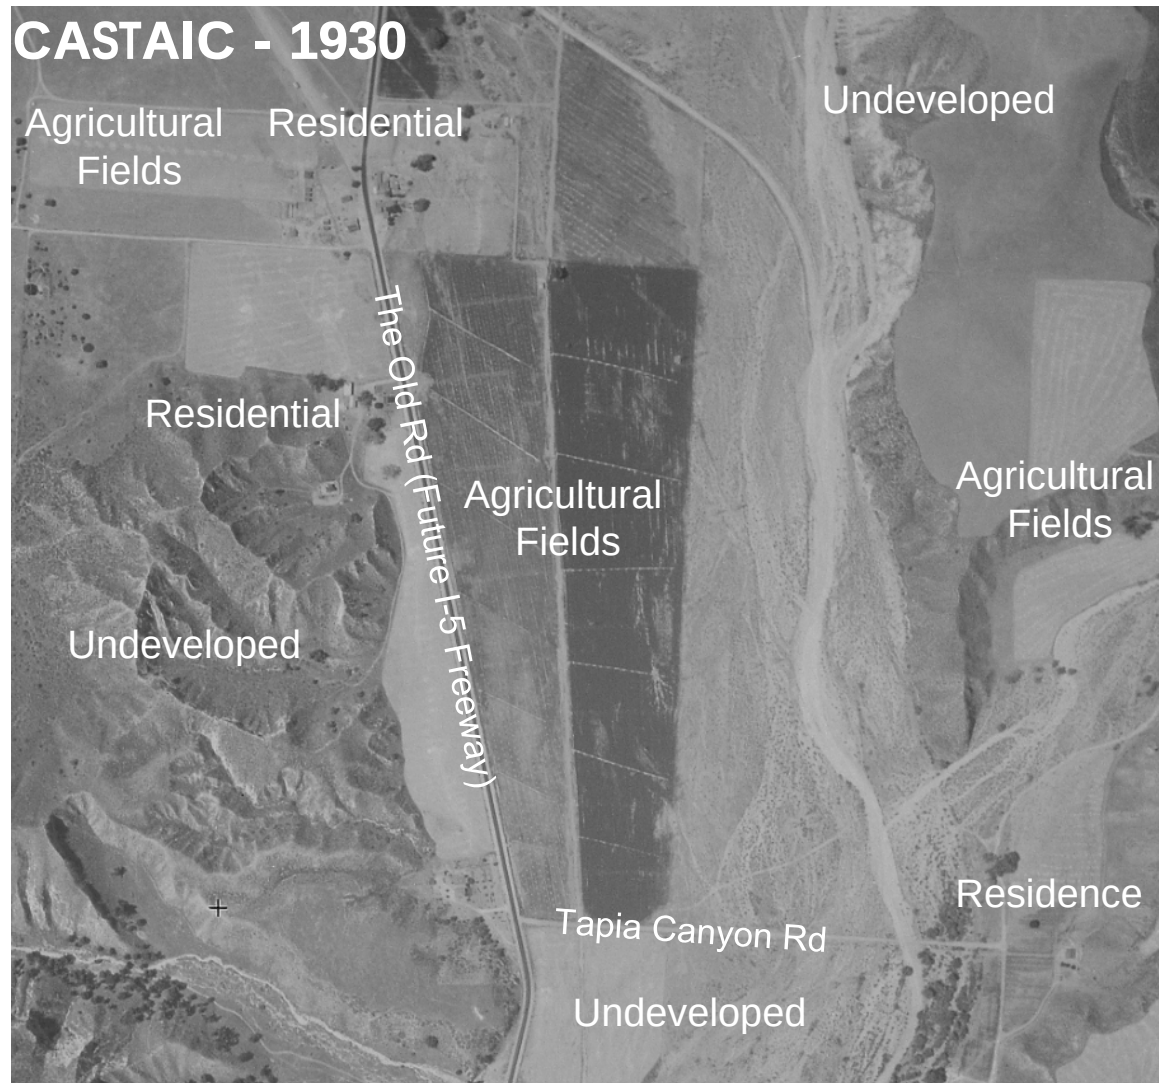
## CASTAIC - 1930

- Aerial image taken on July 18, 1930.
- Scale = 1:18,000
- The Site appears to be used for agriculture.
- Site vicinity is largely undeveloped with some agricultural land use.

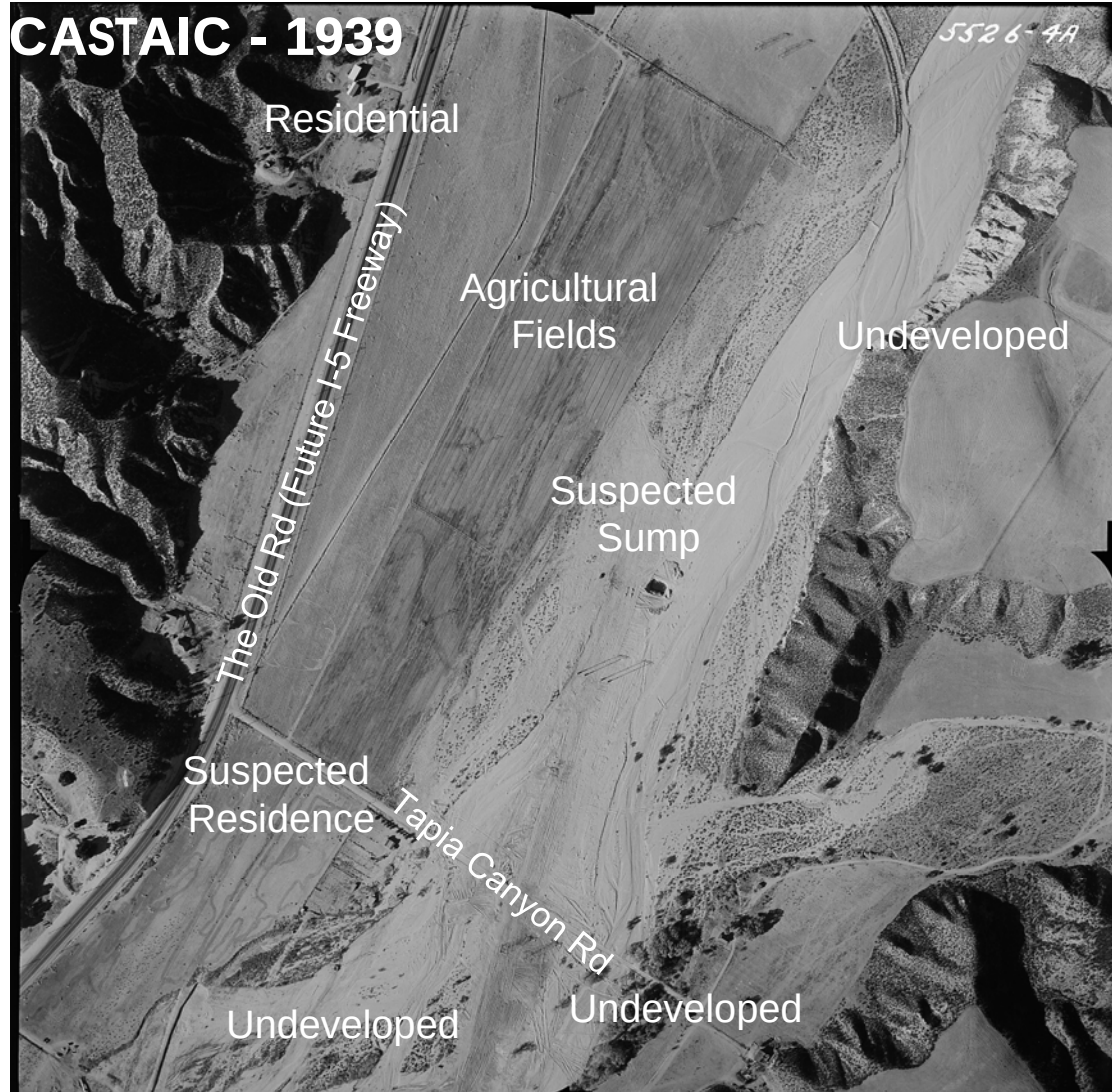
## CASTAIC - 1939

- Aerial image taken on January 1, 1939.
- Scale = 1:4,800
- The Site appears to remain as agricultural.
- Electrical power lines are present.
- Unknown sump-like feature appears along the east side of the property.
- A suspected residence appears directly south of the Site.

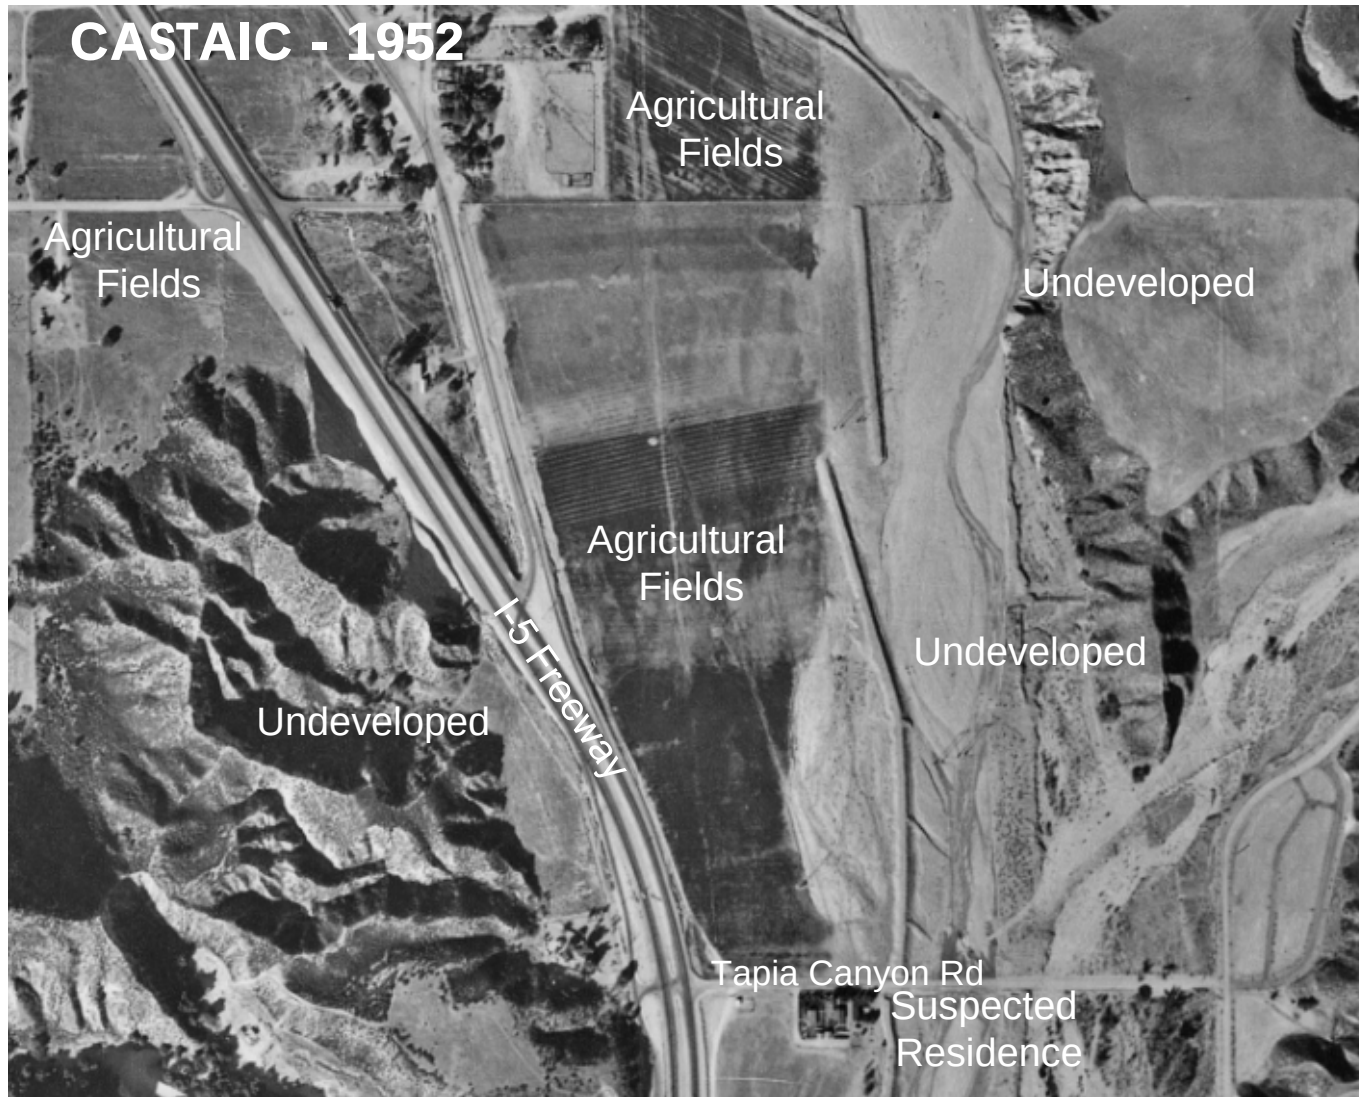
## CASTAIC - 1952

- Aerial image taken on November 3, 1952.
- Scale = 1:20,000
- The Site appears to remain as agricultural.
- A suspected oil derrick appears on the Southern end of the Site.
- Some expansion of residential and agricultural land use to the northwest of the Site.

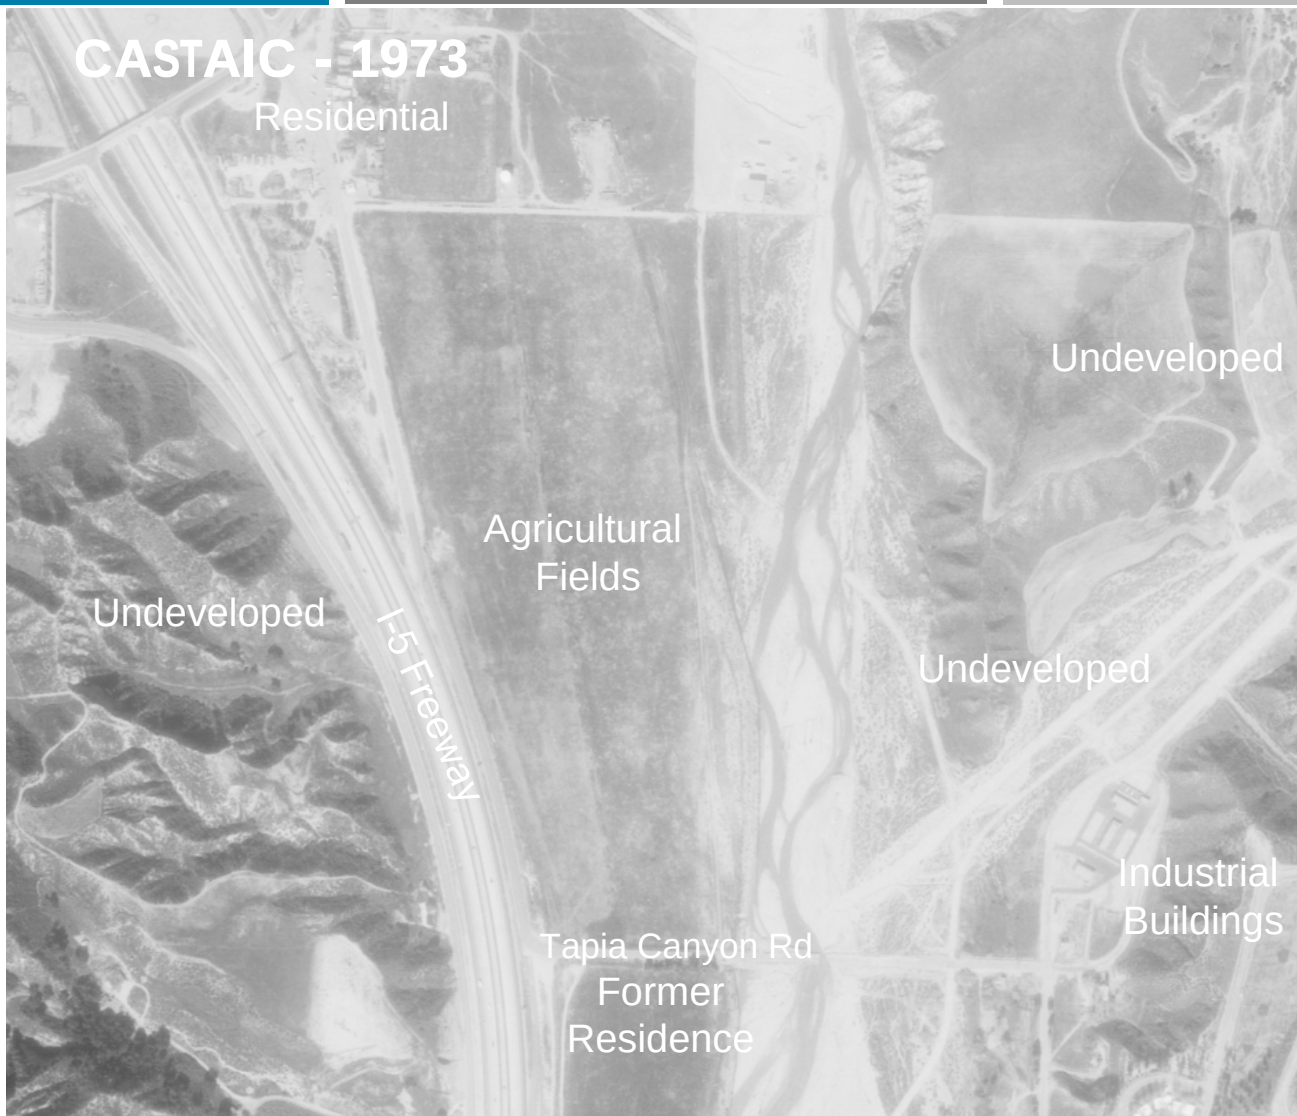
## CASTAIC - 1973

- Aerial image taken on February 19, 1973.
- Scale = 1:24,000
- The Site appears to remain as agricultural.
- Oil field activities are not obvious on the Site, but suspected industrial buildings are present to the southeast of the Site.
- Suspected residence to the South of Site is no longer present.
- Further expansion of residential land use to the northwest of the Site.

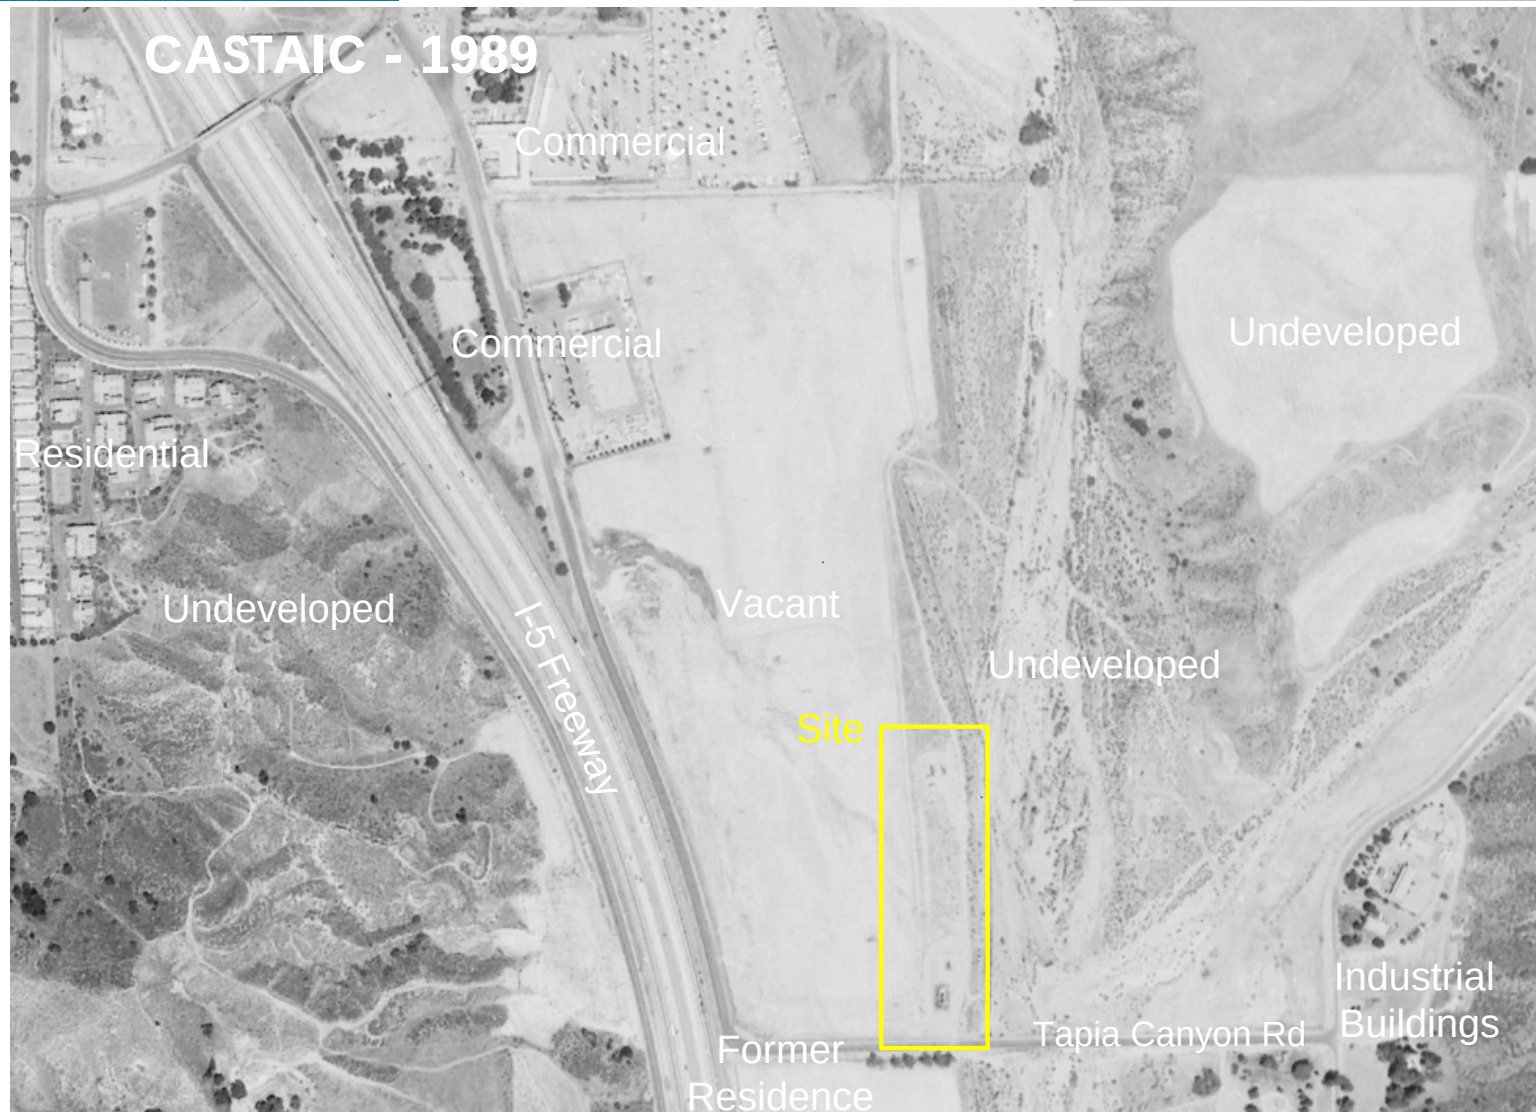
## CASTAIC - 1989

- Aerial image taken on May 26, 1989.
- Scale = 1:31,680
- The Site appears vacant with some commercial development in the northwest area.
- Approximately 2 oil wells appear near the southeast area of the Site.
- Further development of industrial buildings to the southeast of the Site.
- Further expansion of residential land use to the northwest of the Site.
- Commercial development to the north of the Site.

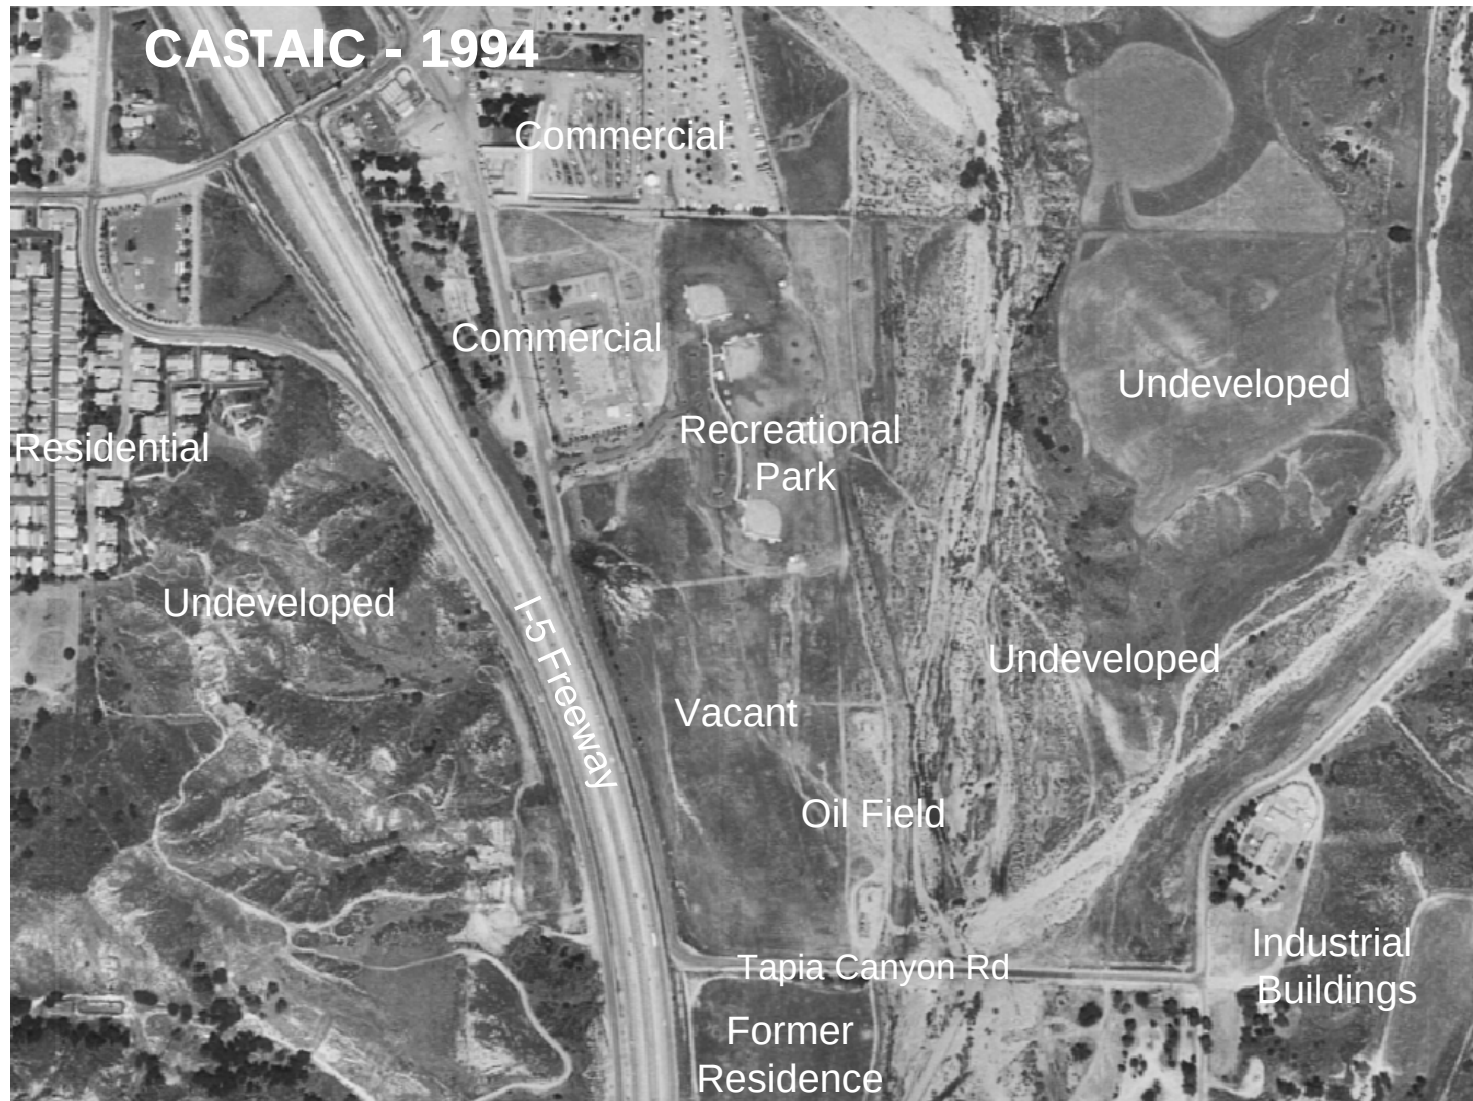
## CASTAIC - 1994

- Aerial image taken on June 1, 1994.
- Scale = 1:40,000
- The northern area of Site is redeveloped into a recreational park; southern area remains undeveloped.
- Oil field activities are present on the southeast area of the Site.
- Industrial buildings remain present to the southeast of the Site.
- Expansion of residential land use to the west, northwest, and south of the Site.
- Commercial development to the north of the Site.
