# MRI for suspected cervical spine trauma

Dr Bob Dempster MBBS, BScHons, FRANZCR

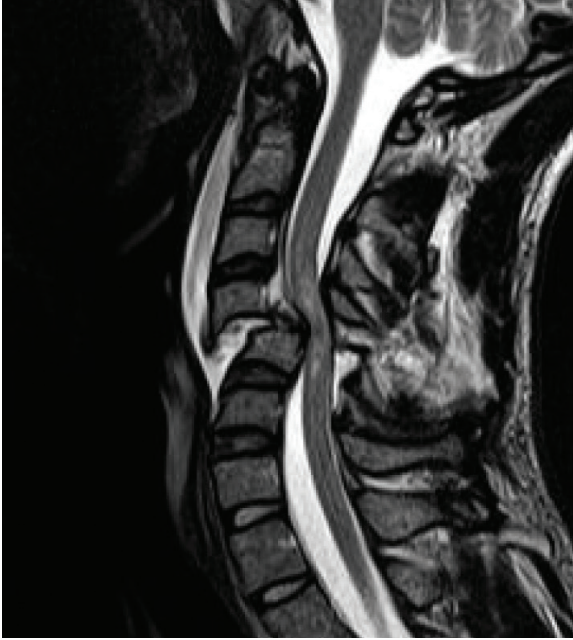
**Figure 1:**  
C4-5 Dislocation  
Ruptured anterior and posterior longitudinal ligaments. Cord compression and oedema. Prevertebral haematoma. Ruptured interspinous ligaments. (Wikipedia)

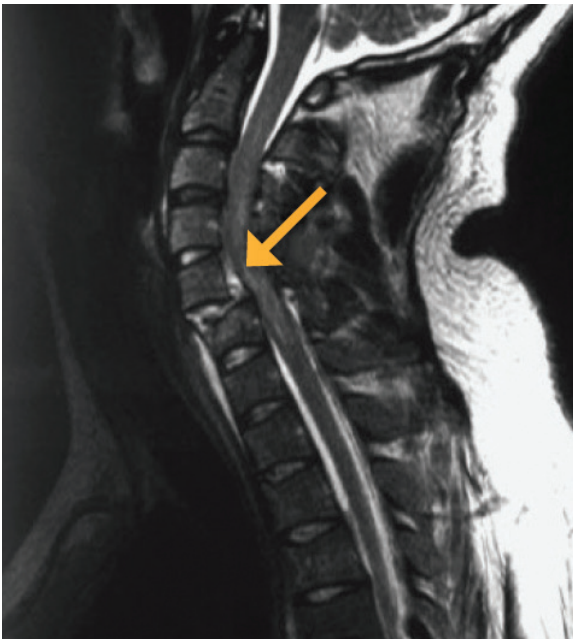
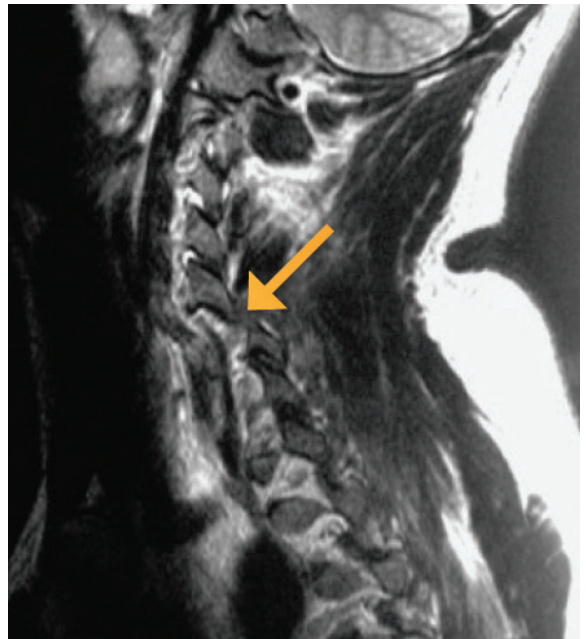
**Figure 2**

**Figure 2:**  
Subluxation C5-6  
Ruptured posterior longitudinal ligament. Cord oedema. Facetal dislocation. (Kerr Seminars Musculoskeletal Radiology 2006)

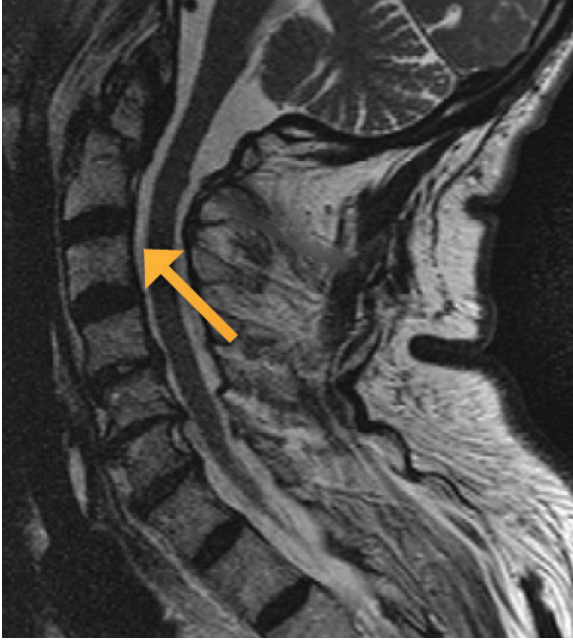
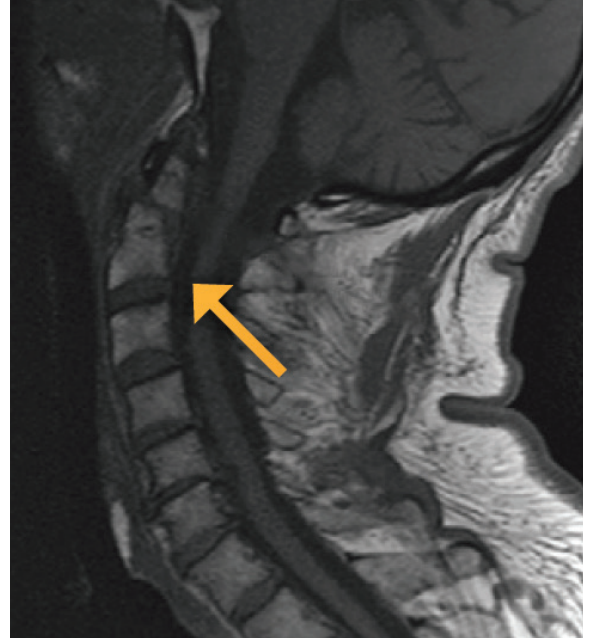
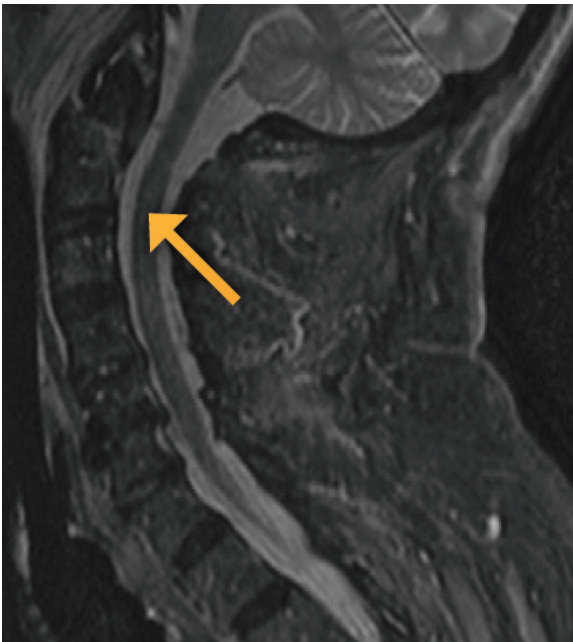
Figure 3a:  
Displaced fractured odontoid posterior  
longitudinal ligament intact. Cord intact. (Looby  
Radiology Clinics Nth America 2011)

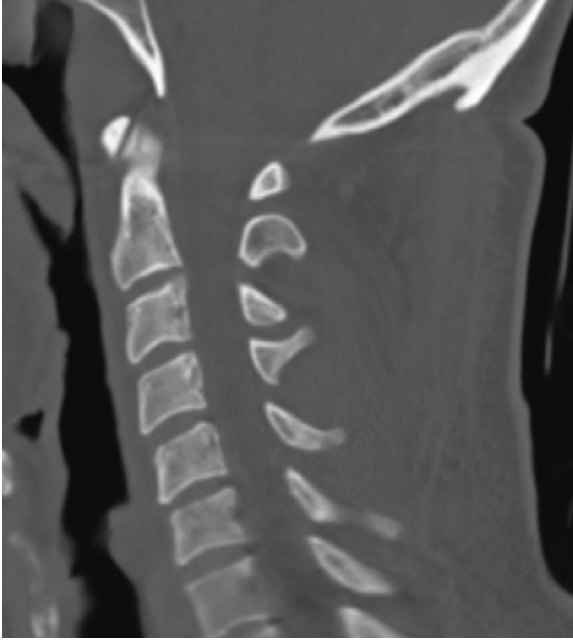
**Figure 4a:**  
Patient with neck pain after high speed collision: CT normal.

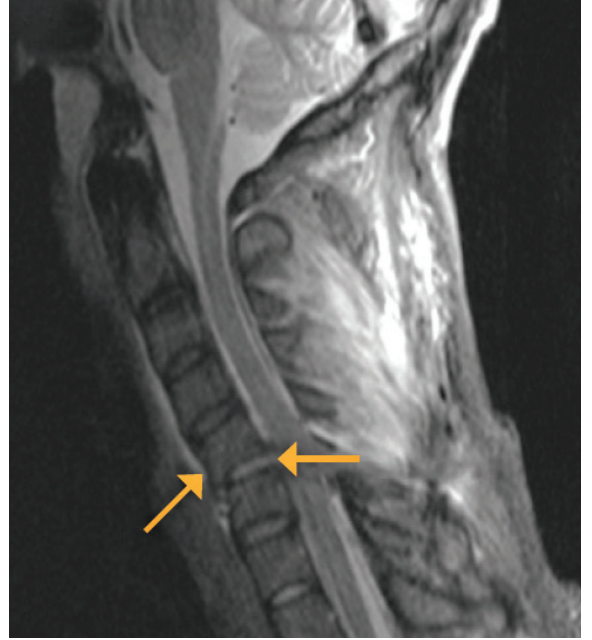
**Figure 4b:**  
MR shows C5-6 subluxation, anterior longitudinal ligament, posterior longitudinal ligament and interspinous ligament disruption.

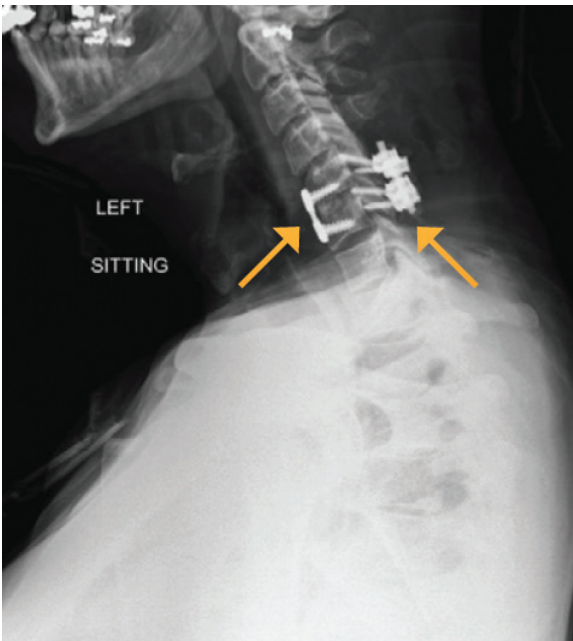
**Figure 4c:**  
Post orthopaedic fixation.  
(Looby Radiology Clinics Nth America 2011)

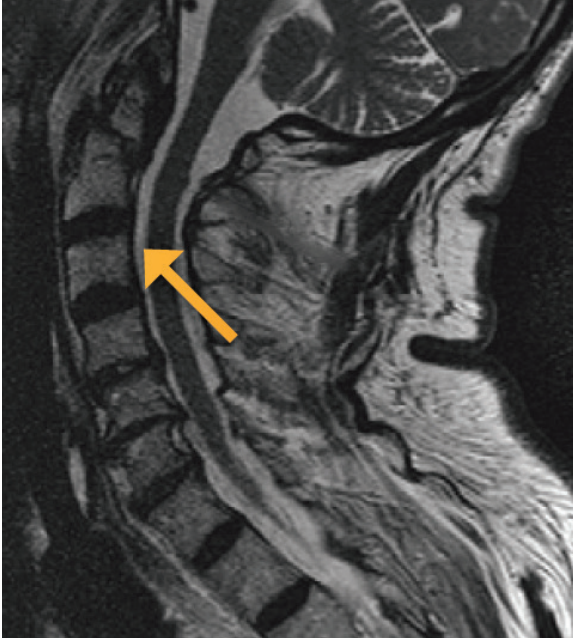
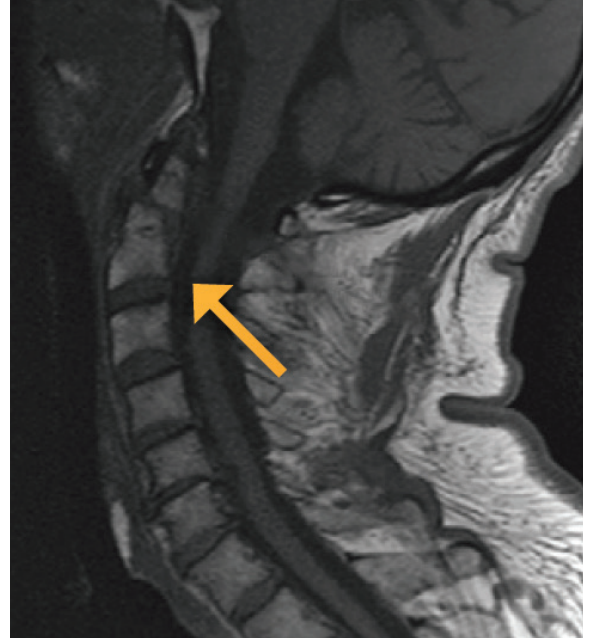
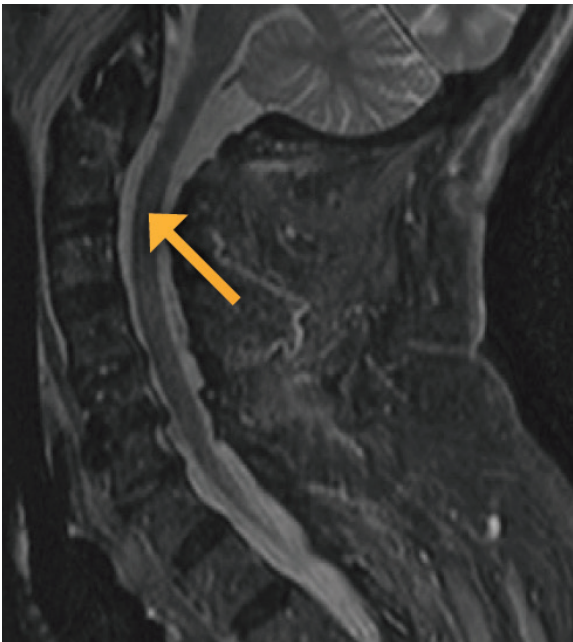
Figure 5a:  
Whiplash Injury. Subtle compression fractures  
and oedema T1 and T2.(Anderson Radiology  
2012)

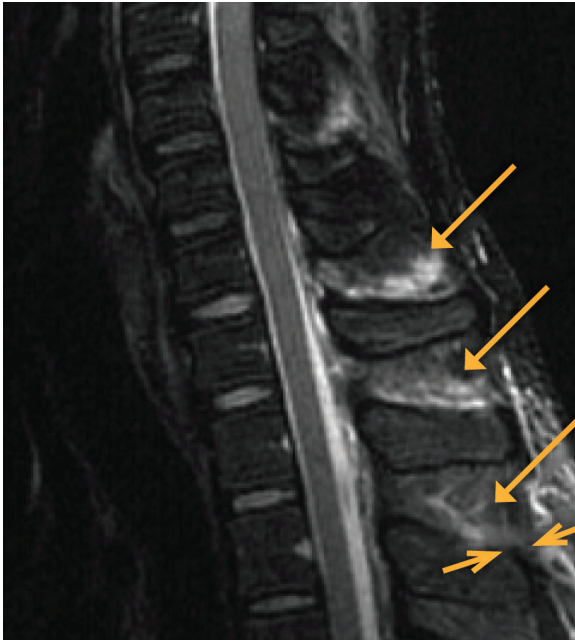
**Figure 6:**  
Whiplash Injury  
Torn interspinous ligaments C6-7-T1-T2.  
(Minz Seminar Musculoskeletal Radiology 2004)

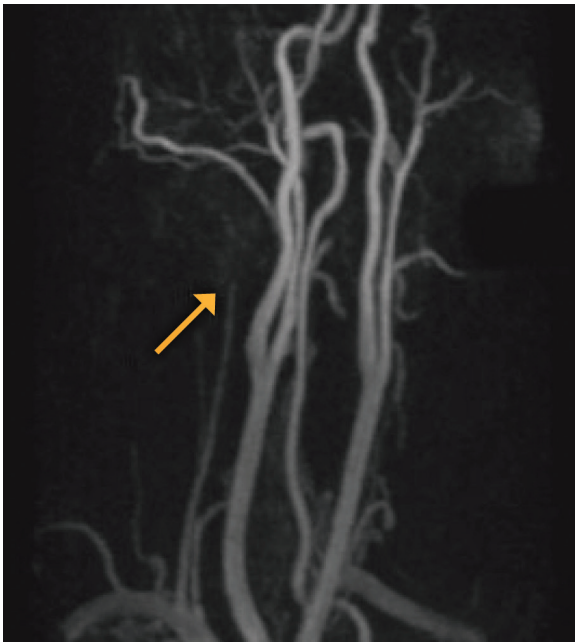
**Figure 8:**  
Occluded right vertebral artery in a patient with a C1 fracture.  
(Castillo Applied Radiology 2007)

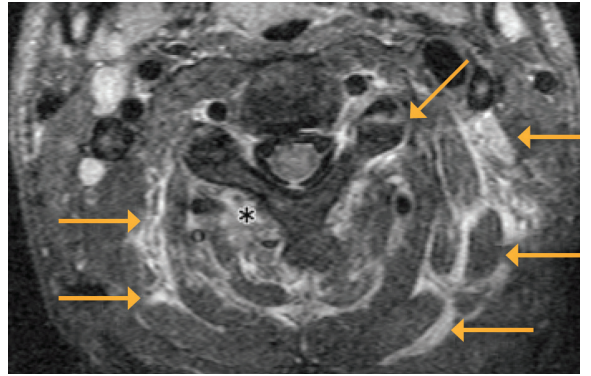
**Figure 7:**  
Whiplash Injury. Extensive intermuscular haematoma. Damaged left C2-3 facet joint.  
(Anderson Radiology 2012)

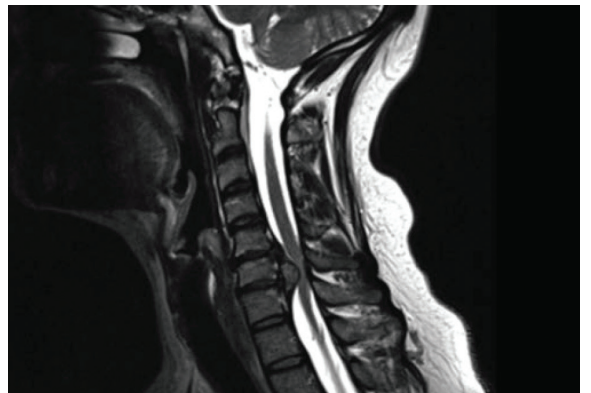
**Figure 9:**  
Acute disc protrusion with cord compression.

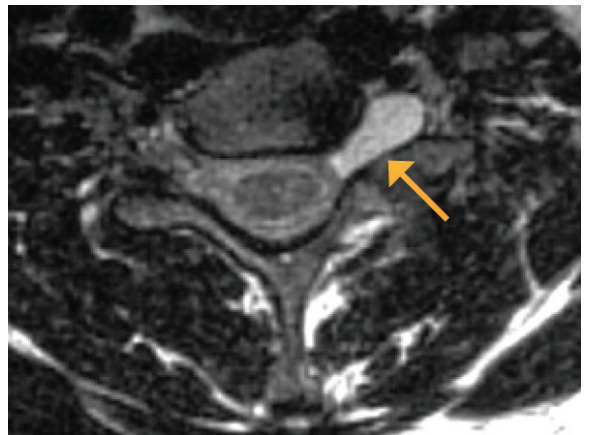
**Figure 10:**  
Left T2 nerve root avulsion with pseudomeningocele.  
(Minz Seminar Musculoskeletal Radiology 2004)

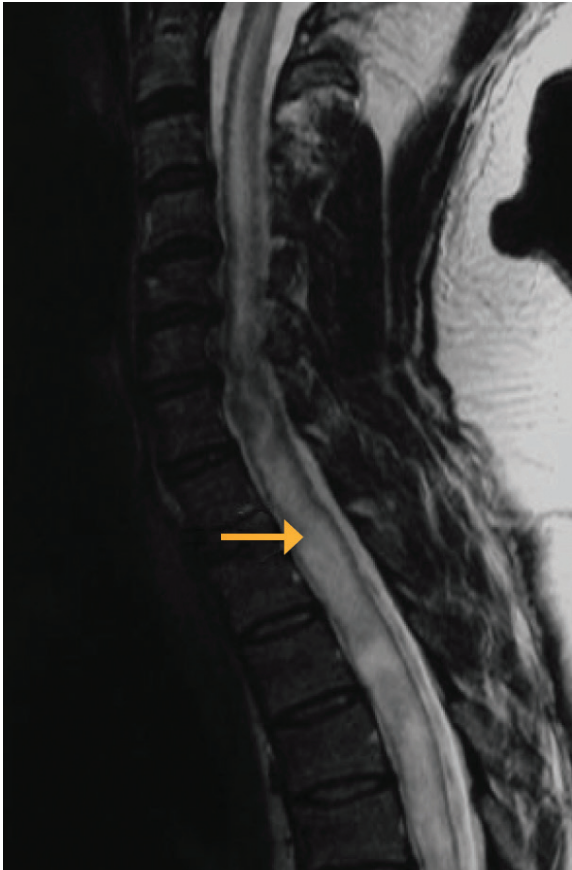
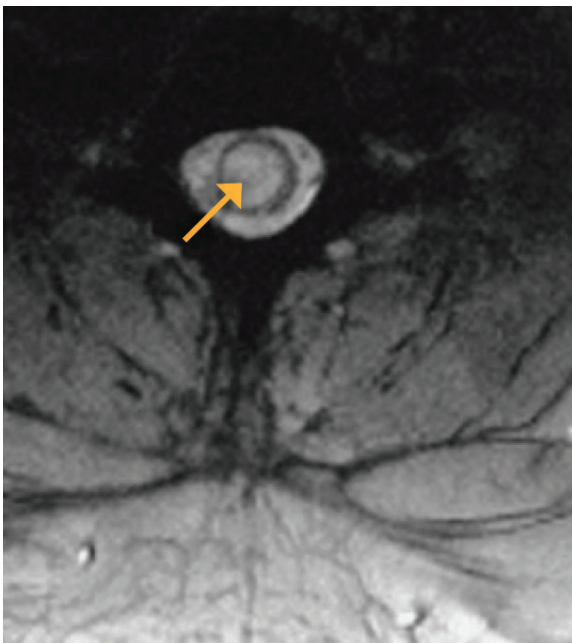
**Figure 11a:**  
Chronic post traumatic  
syringomyelia following severe cord trauma with  
paraplegia 20 years previously.  
(Kerr Seminar Musculoskeletal Radiology 2006)
