**I-MED Radiology
Network**

Case study

Investigating shoulder injuries

Dr Tim Dunshea MBBS, FRANZCR
Radiologist, I-MED Radiology

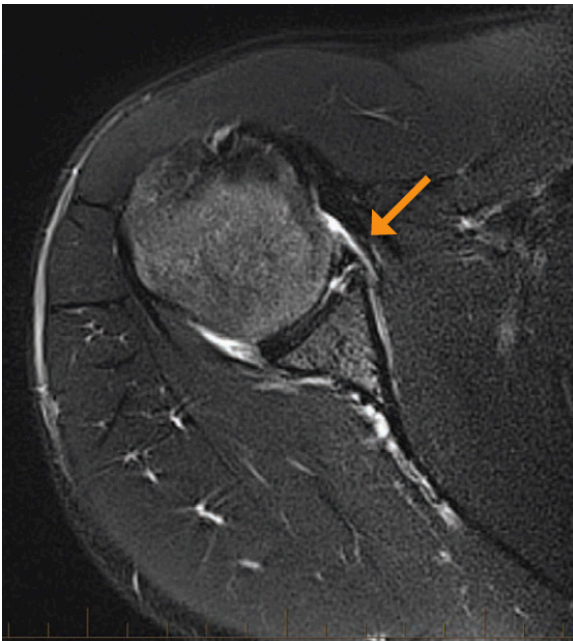
Figure 2:
Patient with previous anterior dislocation and a Bankart lesion. Cleft of high signal (arrow) indicating a tear at the antero-inferior corner of the labrum. Importantly there is no underlying glenoid fracture (bony Bankart lesion).

There are two common types of labral tear. Firstly, the superior labral or SLAP (superior labral anterior to posterior) tear, which can be due to acute or repetitive trauma. Secondly the Bankart lesion (usually anteroinferior) which is commonly associated with anterior shoulder dislocation. Each of these have several variants, and give symptoms of pain and instability.
