# ANNEX A – SCC BOREHOLE TESTING REPORT

# SS Dicky Geotechnical Investigations 08/10/2014

On the 8<sup>th</sup> October 2014 Cardno Bowler and Council officers underwent geotechnical investigations in the immediate area surrounding the SS Dicky. The purpose of the investigations was to see if there was presence of clay material under the wreck.

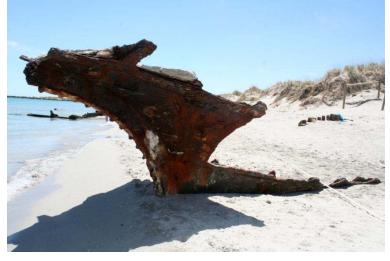
*Figure 47. Prominent section of Wyola with lower section behind to the right.* (Source: Mark Polzer, 3 December 2011).

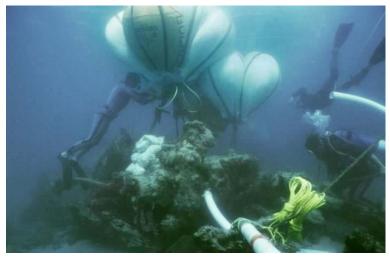
*Figure 49. Lift-bags being used to move the engine off site.* (Source: Western Australian Museum)

The site was first recorded manually and with 2D and 3D photography. Thermal lance equipment was then used to cut around the engine, with the lance creating neat cuts of around 25 mm width and proving successful although somewhat difficult to use underwater. The engine was then slowly settled onto pre-positioned timbers below it to prepare for the lift.<sup>125</sup> The 7.4 tonne engine was stropped with thick mooring rope in 120 mm wide lifting strops and sand bags to cushion the concretion between.<sup>126</sup> Lifting bags were attached, and the engine was raised and towed to a steel sled positioned in shallow water which was then dragged ashore (Figure 49).<sup>127</sup>

Difficulties encountered included a slight swell which, while the engine was being lifted, caused it to rock alarmingly inside the very limited work space available. Other than this

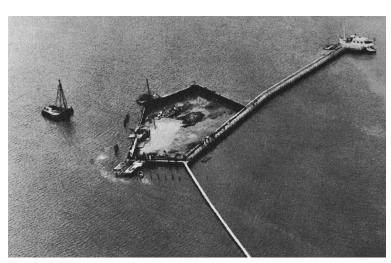
Figure 50. Cofferdam in Roskilde Fjord constructed during 1962 for excavation and recovery of five Viking ships.<sup>134</sup>

In the mid-1950s, some timbers that had been raised by divers from the Roskilde fjord, an inlet on the northern coast of the Danish island of Zeeland, were identified by the National Museum at Copenhagen as originating from the Viking period. This led to a major archaeological investigation in 1962 of five Viking ships which had been sunk to block a channel.<sup>132</sup> As the fjord in this area is less than 3 feet (1 m) in depth and its waters were so muddy, it was decided to build a cofferdam around the five wrecks and pump out the water (Figure 50). Catwalks were positioned over the top of the cofferdam and enabled archaeologists to excavate the wrecks from above. Although this cofferdam worked well to aid excavation, its low walls were almost breached in storm conditions.<sup>133</sup>

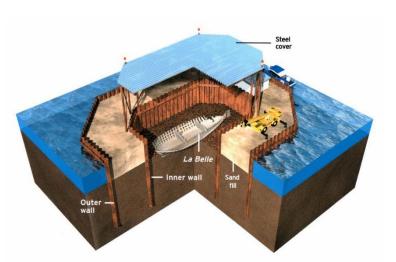
Figure 51. Cutaway showing elements of the cofferdam construction.<sup>139</sup>

The wreck was submerged only 12 feet (3.7 m) below the surface but visibility was especially poor. The other main concern was that the wreck had been buried for over 300 years and the material would require careful and immediate conservation. For these reasons it was decided to excavate the wreck inside a specially designed metal double-walled cofferdam, at a cost of over US\$2 million (Figure 51 and Figure 52.<sup>137</sup> It took six months to build the cofferdam, made of two concentric walls of interlocking steel sheet piling driven 40 feet (12.2 m) into the bed of the bay. Tons of sand were then poured into the gap to form a wall and the water was drained. The presence of leaks was overcome with sump pumps at the bottom of the cofferdam. Excavations lasted eight months.<sup>138</sup>

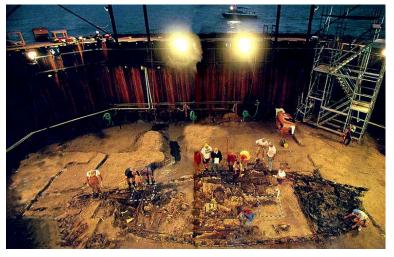
Figure 52. Archaeological excavation inside the cofferdam walls.<sup>140</sup>

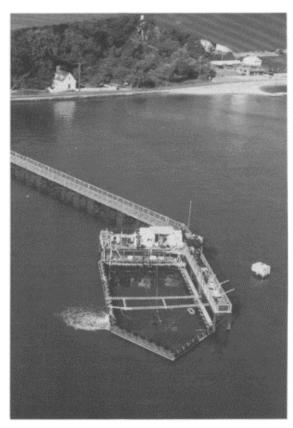
Figure 55. Yorktown cofferdam schematic, 1988.<sup>148</sup>

The rigid steel bund was to surround the shipwreck and contain filtration systems to clarify the enclosed water in order to excavate. Public access was encouraged with a connecting pier to shore and interpreters on site. First the piles were placed, and then the bund constructed of interlocking sheet-steel pilings to form an enclosure. Unfortunately, river water leaked through seams in the bund wall and came through the river bottom, mixing with the interior water. Pool filters, filtration systems, salt and chorine were used to clean the water but were unsuccessful. Experiments were made with different types of sealing and, although none eliminated the contaminating water, it did reduce it to a manageable level. After two years of making improvements to the bund, a large filter company supplied assistance and some commercial sized pool filters which improved the conditions. In 1982, the first year of the establishment of this bund, it had cost US\$412,000, although this was substantially increased by the need to pile 80 to 100 feet deep. It was completed in 1985 and stood until 1990 when the site was backfilled and the cofferdam removed (Figure 54 and Figure 55).<sup>146</sup>

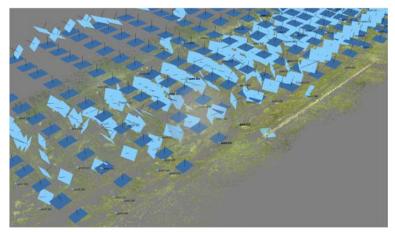
Figure 56. A detail of the point cloud extracted from the photoset. Colour squares mark reconstructed camera positions, blue for straight photos and cyan for oblique photos.<sup>154</sup>

Photographs were captured using a boxed DSLR full-frame camera from straight and oblique angles, taken at 0.5 to 1 m distance (Figure 56). Railing across the site was used in combination with a moving platform to ensure complete coverage and stable positioning for the straight shot photos. Three sets of photos were taken at different spacings to achieve sufficient overlap. The eventual 663 selected images were processed by point matching software, with only the densest set of photos successfully matched (0.4 to 0.5 m spacing).<sup>153</sup>

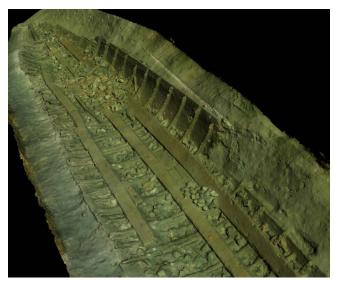
Figure 57. Shaded render of the ship's 3D model.<sup>156</sup>

Photogrammetry was used with high efficiency to record this shipwreck, demonstrating the capability of automated point cloud extraction software to create precise models of underwater sites in poor conditions. Techniques involved in the successful use of this application underwater involved extensive photo coverage with 50-60% overlap, use of high quality camera optics and presence of distinct control points with measured coordinates (Figure 57).<sup>155</sup>

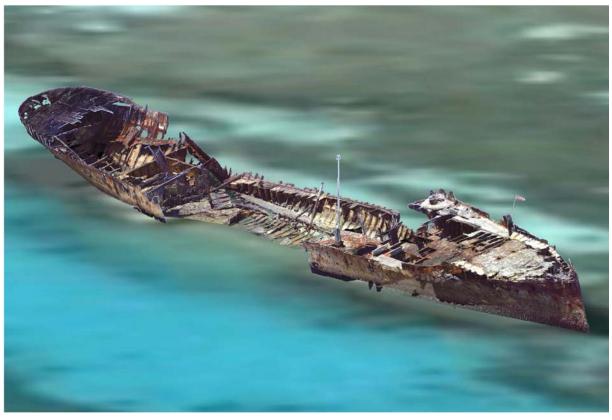
Figure 58. Screen capture of 3D digital model of Protector's external hull.<sup>159</sup>

A team of researchers conducted a comprehensive archaeological survey of the wreck in 2013. Digital video, 3D photogrammetry and laser scanning was undertaken to capture the extent of *Protector* above the water line. Traditional methods of manual recording, video and photography were also employed. It is intended for the findings to be generated into 3D digital and physical models (Figure 58).<sup>158</sup>
